# Pipeline High Accuracy Detection Technology

## Panoramic Quantitative Robot

Wuhan Easy Sight Technology Co.,Ltd.

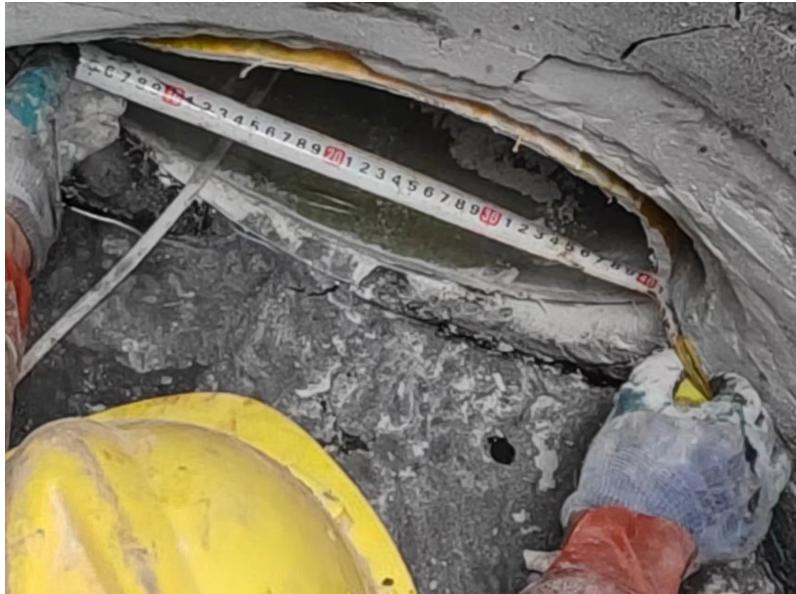
The liner size is too small: **the liner does not fit the pipe to be repaired**

At a project site, the ordered liner size is DN415, and the actual pipe diameter is DN440. After the curing is completed, the liner does not fit the pipe to be repaired at all.

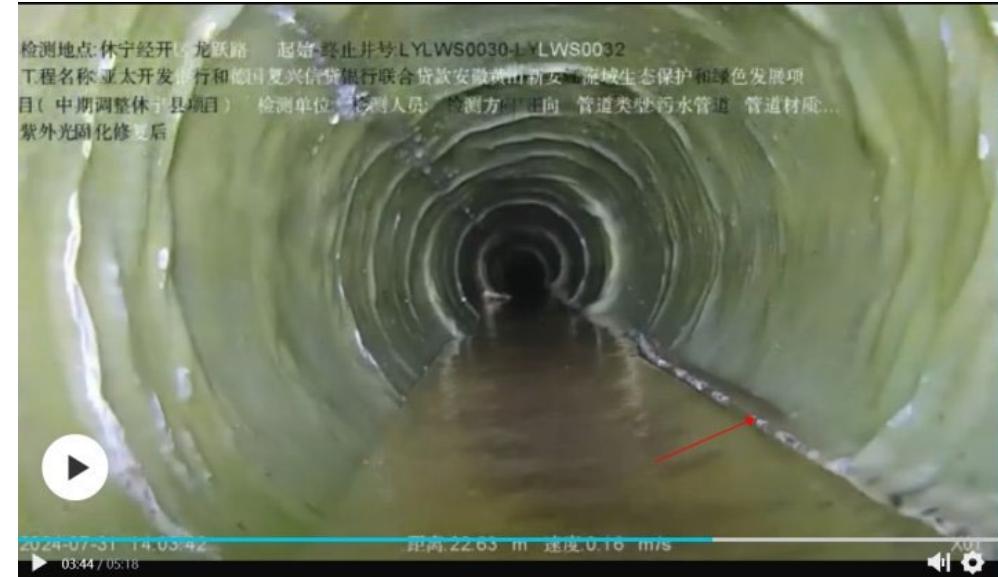
The liner size is too large: **the liner expands and forms radial extrusion**

At a project site, the ordered liner size is DN300, and the actual pipe diameter is DN270. After curing, there are a lot of circumferential wrinkles inside the pipeline liner.

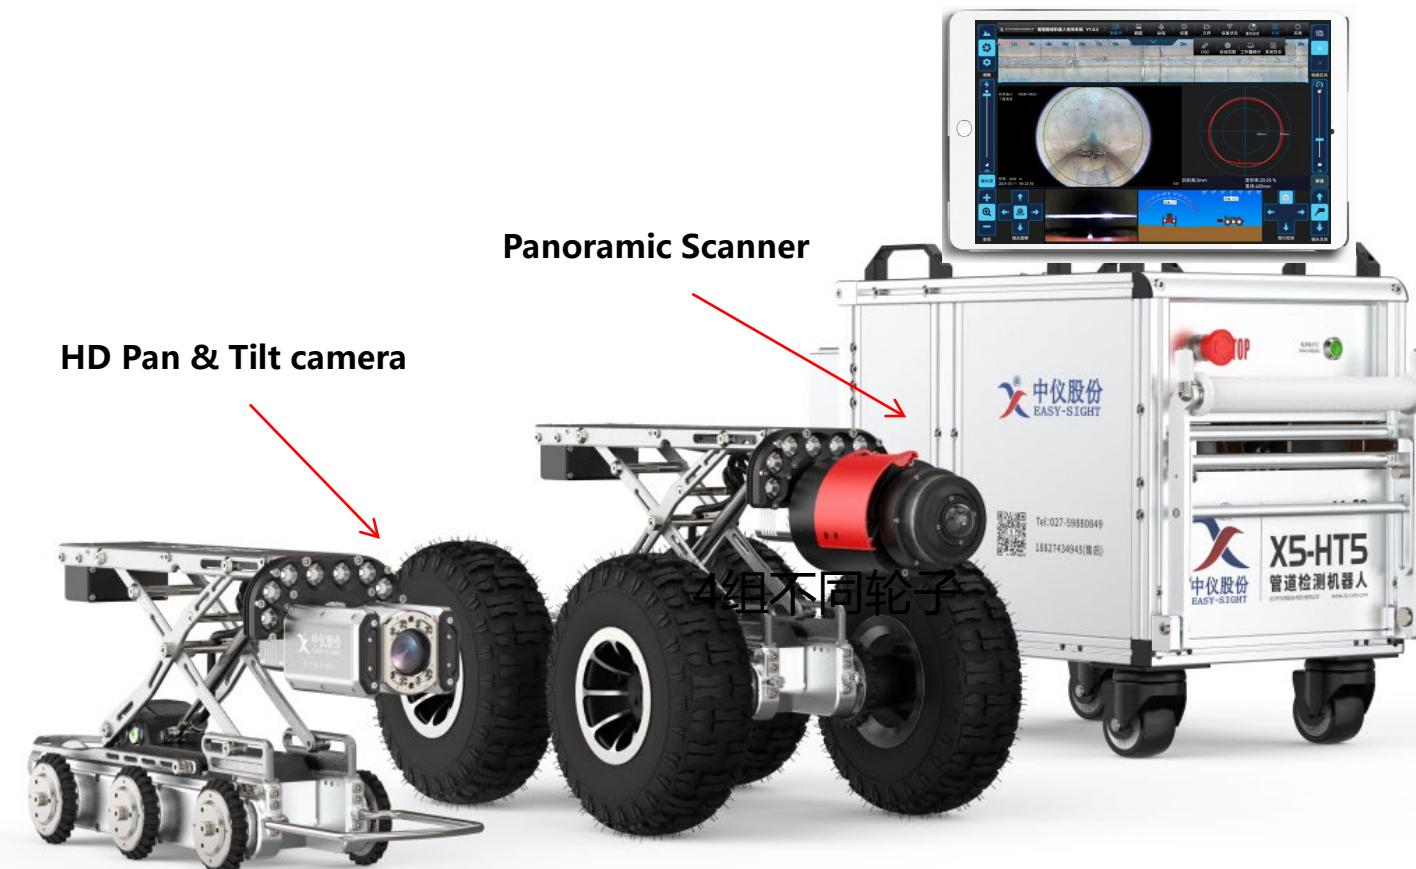
# X5-HT5 Pipeline Inspection Robot

It can perform millimeter-level high-precision measurements of pipeline parameters such as pipe diameter, deformation, deposition, and defect size, providing accurate data support for maintenance and repair operations. It is suitable for engineering measurement tasks that require extremely high accuracy and reliability.

Millimeter-level measurement accuracy

500m long distance detection

190mm height gap X-type electric lift

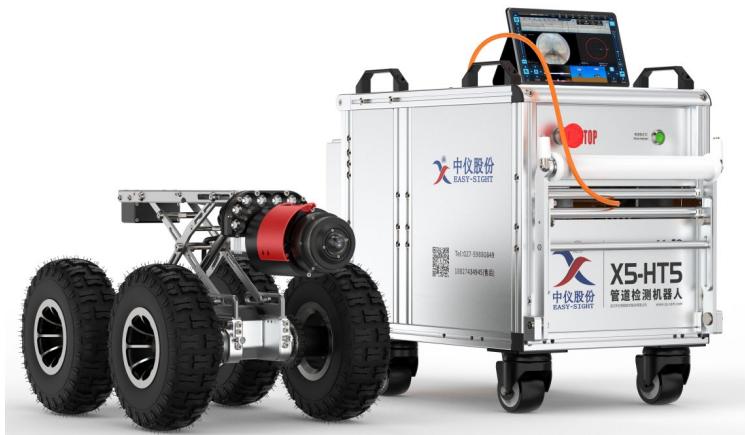
# Technical Features

**Panoramic display:** present the whole view of the pipeline in one picture

**Lidar quantification:** Defects can be accurately quantified

When inspecting, just set the inspection parameters, and the crawler will crawl automatically without stopping, observing defects, or rotating the lens; after the inspection is completed, data is generated and analyzed immediately; When interpreting, interpret and analyze on the pipeline panorama and chromatogram; when clicking on a defect, it will automatically associate with the corresponding video frame and lidar contour data for precise quantification.

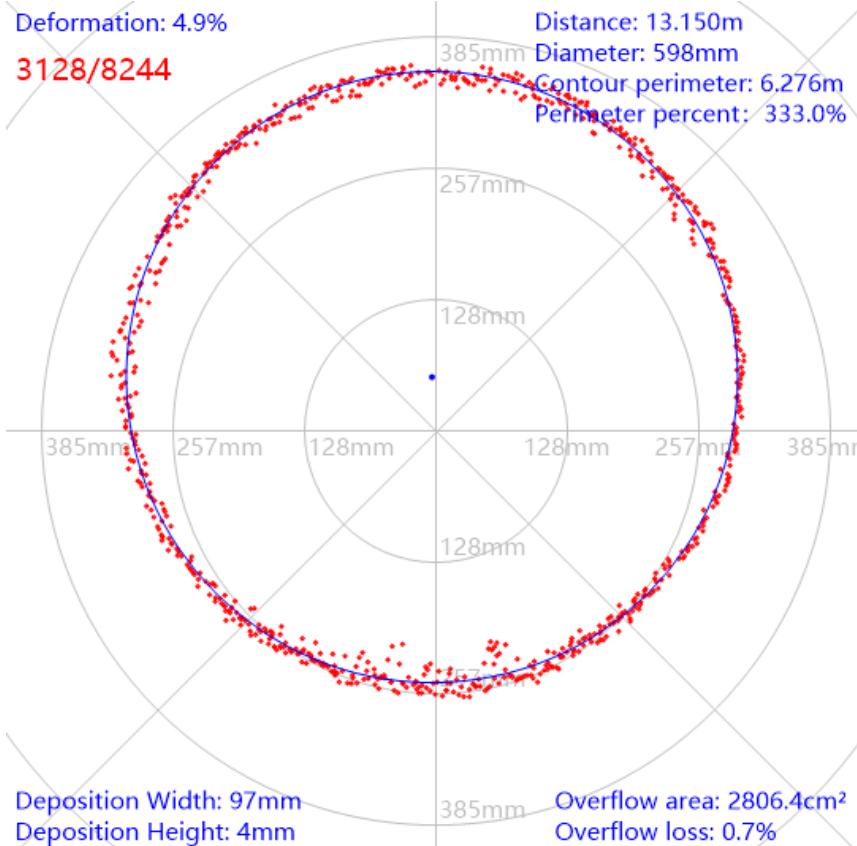
Regular lidar (centimeter grade)

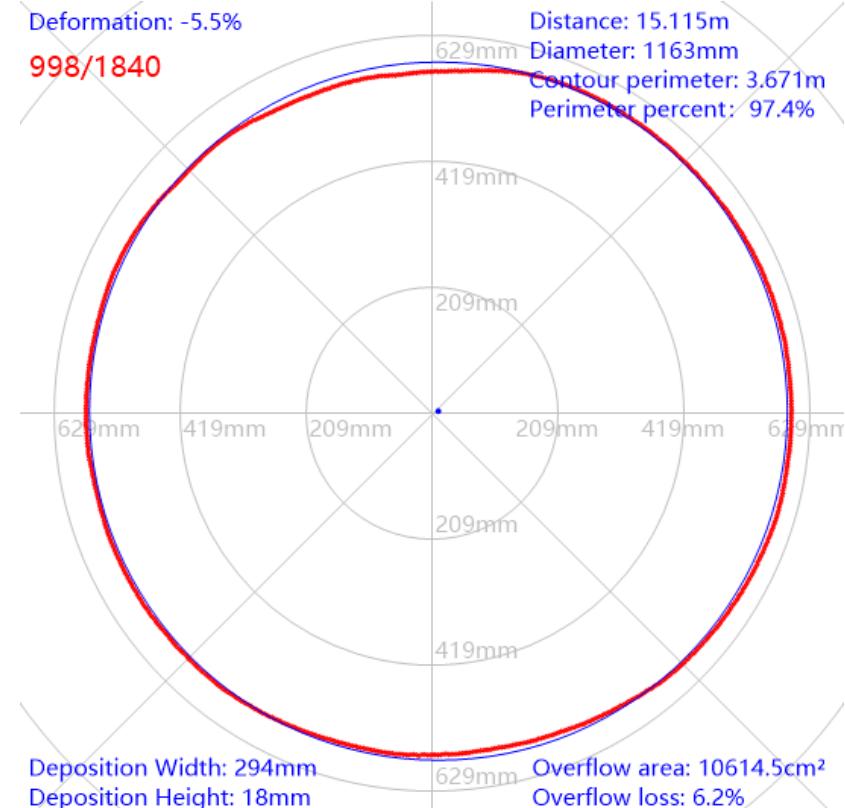
High accuracy lidar (millimeter grade)

The high accuracy lidar collects 800 points per frame, eliminating stray points and making the contours smoother.

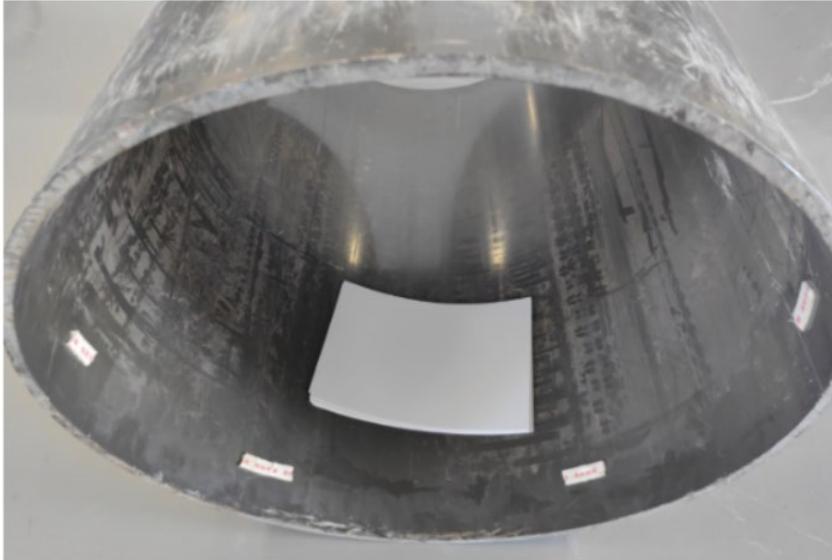
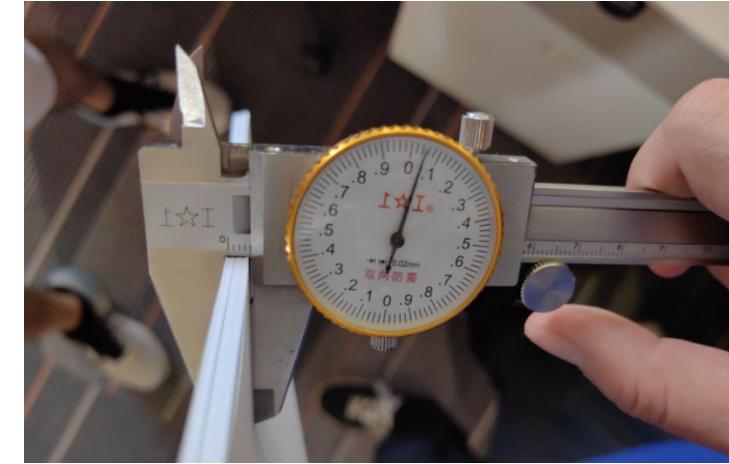
Place the lidar inside the pipe for scanning. Place 5, 10, 15, 20, 25, 30, 35, and 40 A4 papers at the bottom. Measured by caliper, the thickness of 40 papers is 4mm, so the resolution of every 5 papers is 0.5mm.

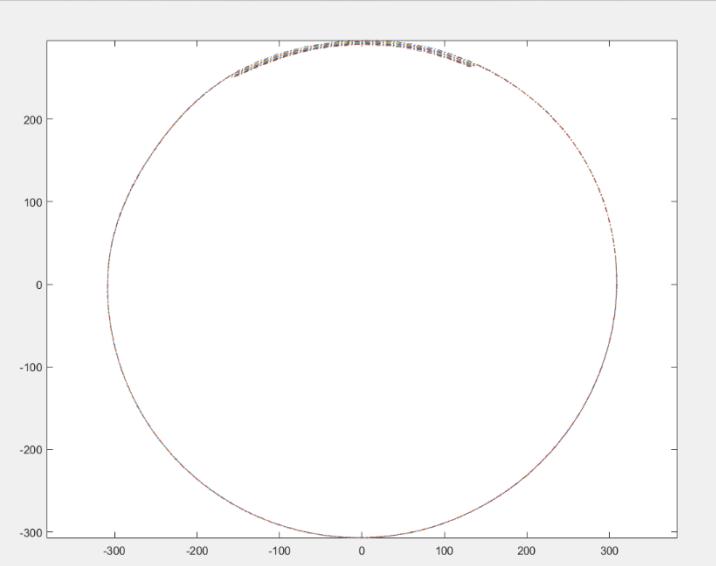
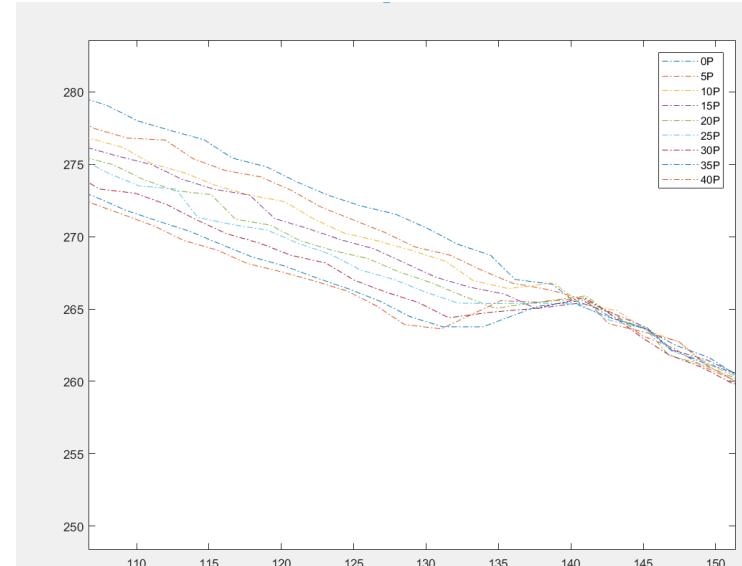
Through data statistics, it was found that there were clear dividing lines between different paper layers, and the display resolution was higher than 0.5mm.

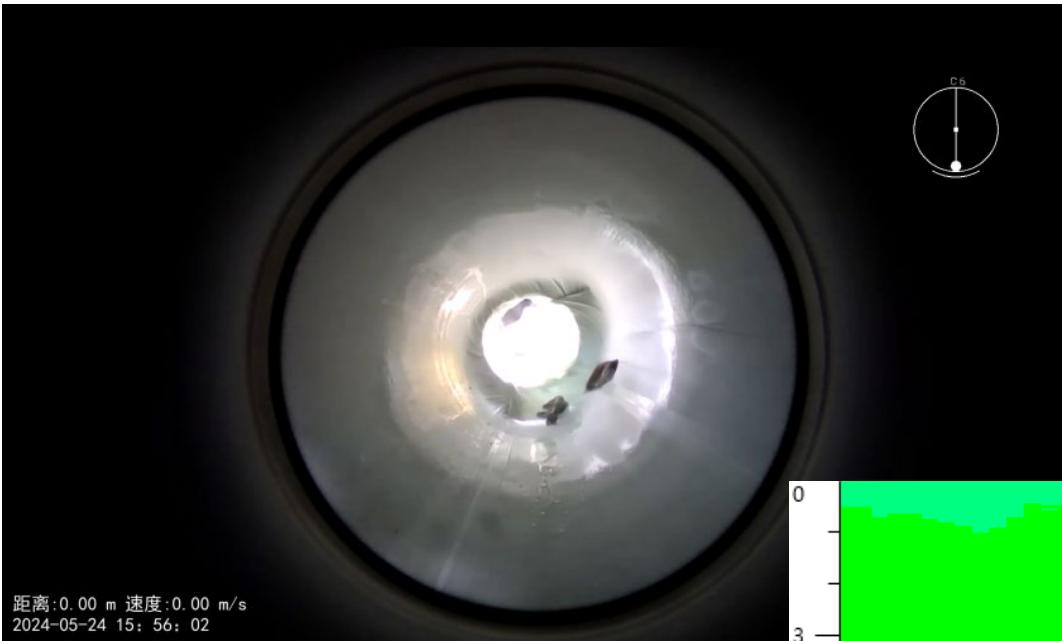
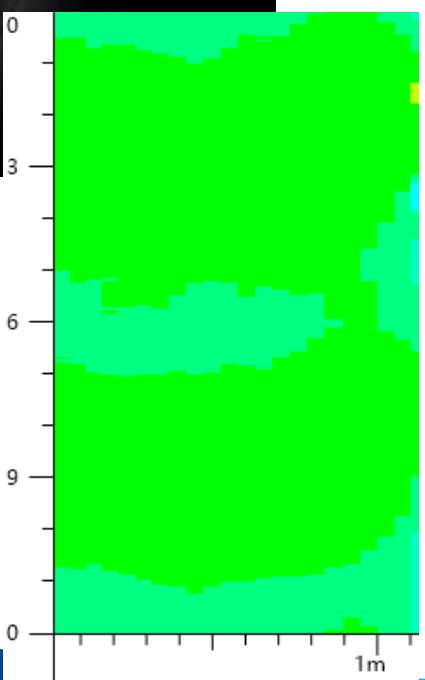
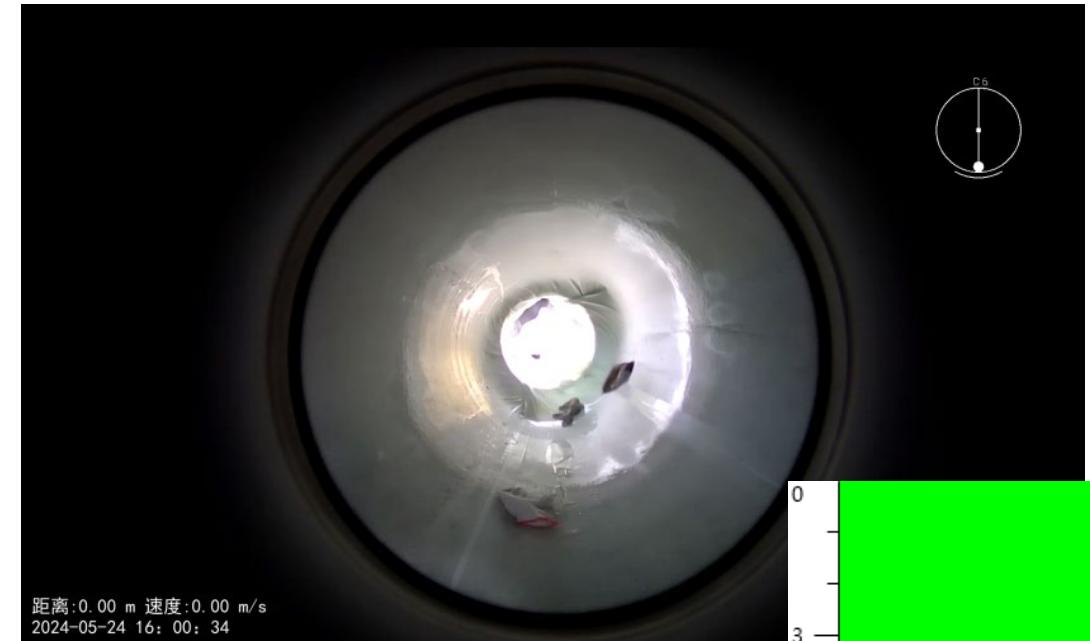
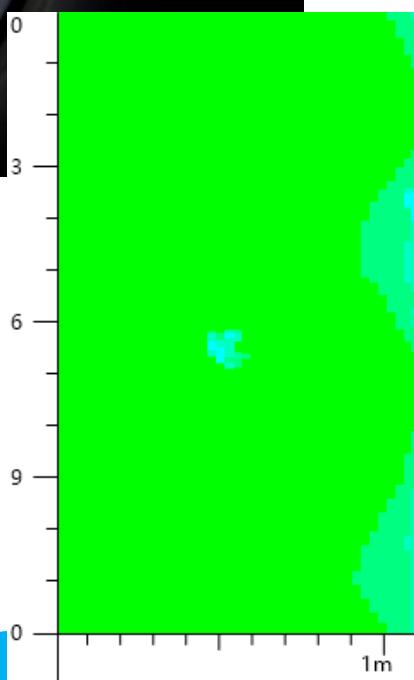
Chromatogram when three  
people are stepping on it

Hong Kong Verification:  
Light-cured repair material for  
DN600 pipe diameter

Chromatogram when no one is  
stepping on it and one glove is  
placed

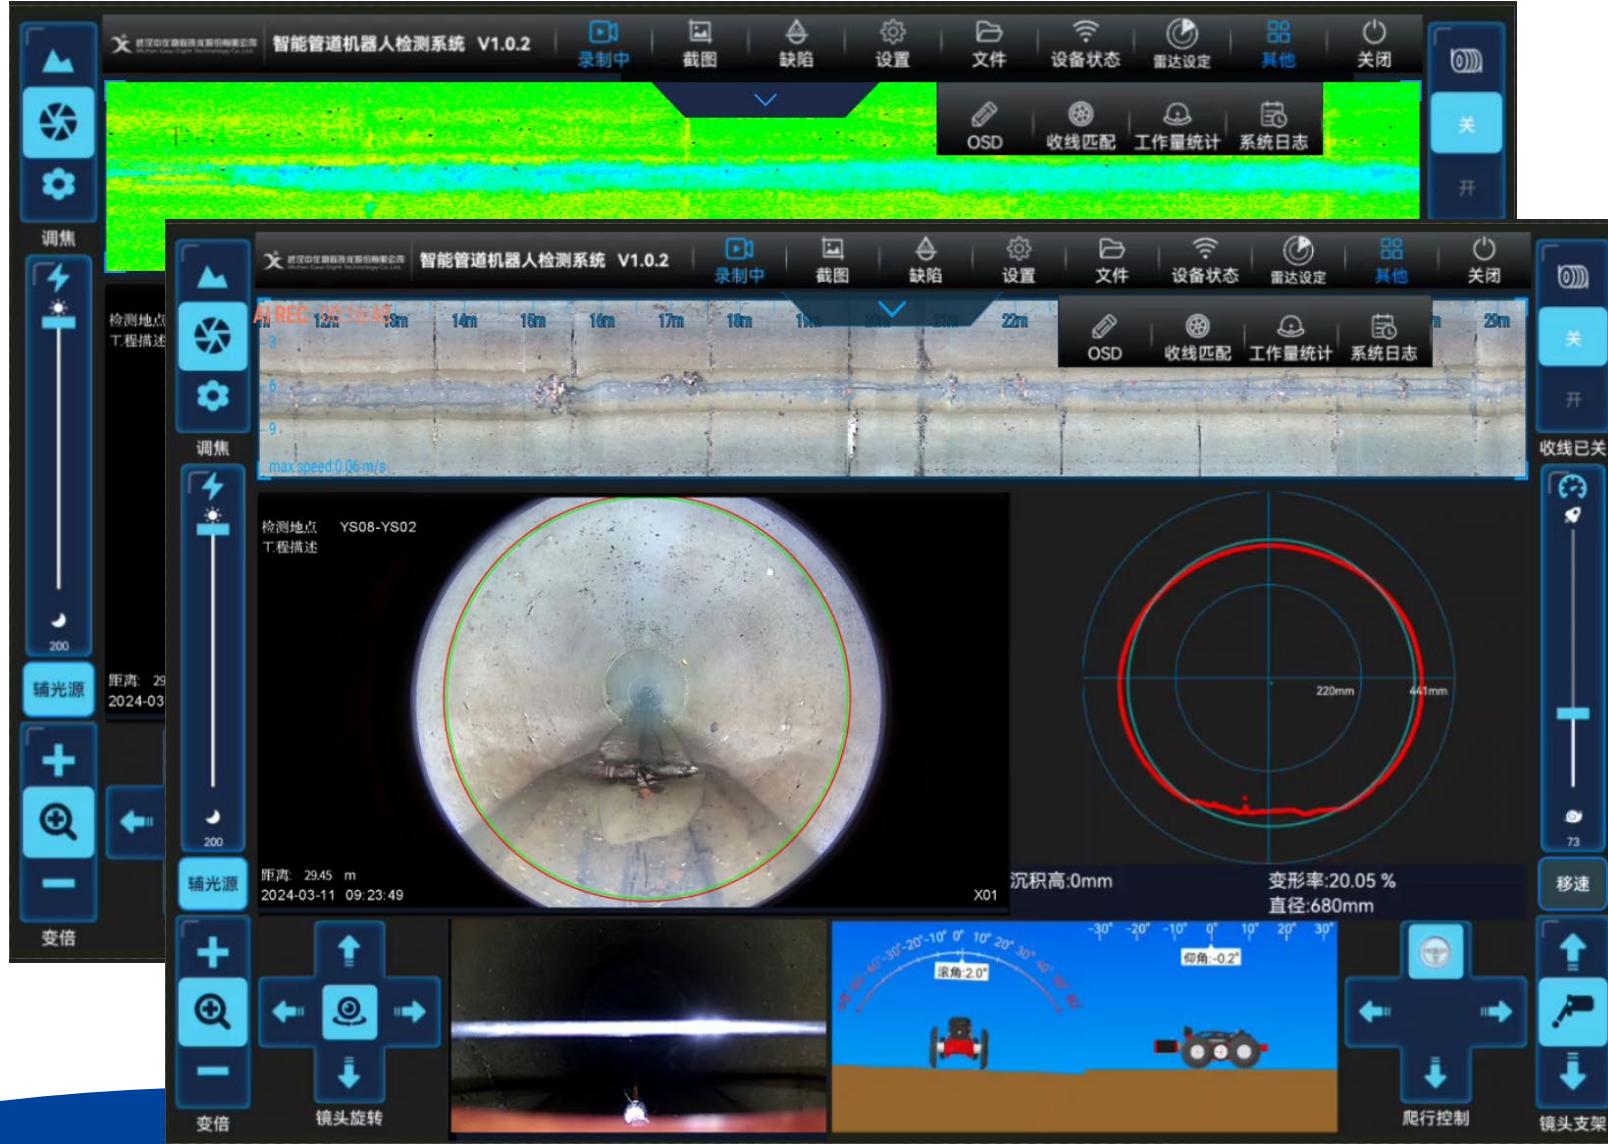
# Data Collection

One test, get multiple data:

- ◎ HD video
- ◎ Lidar Profile
- ◎ Panorama
- ◎ Chromatogram
- ◎ Posture data
- ◎ No post-processing required

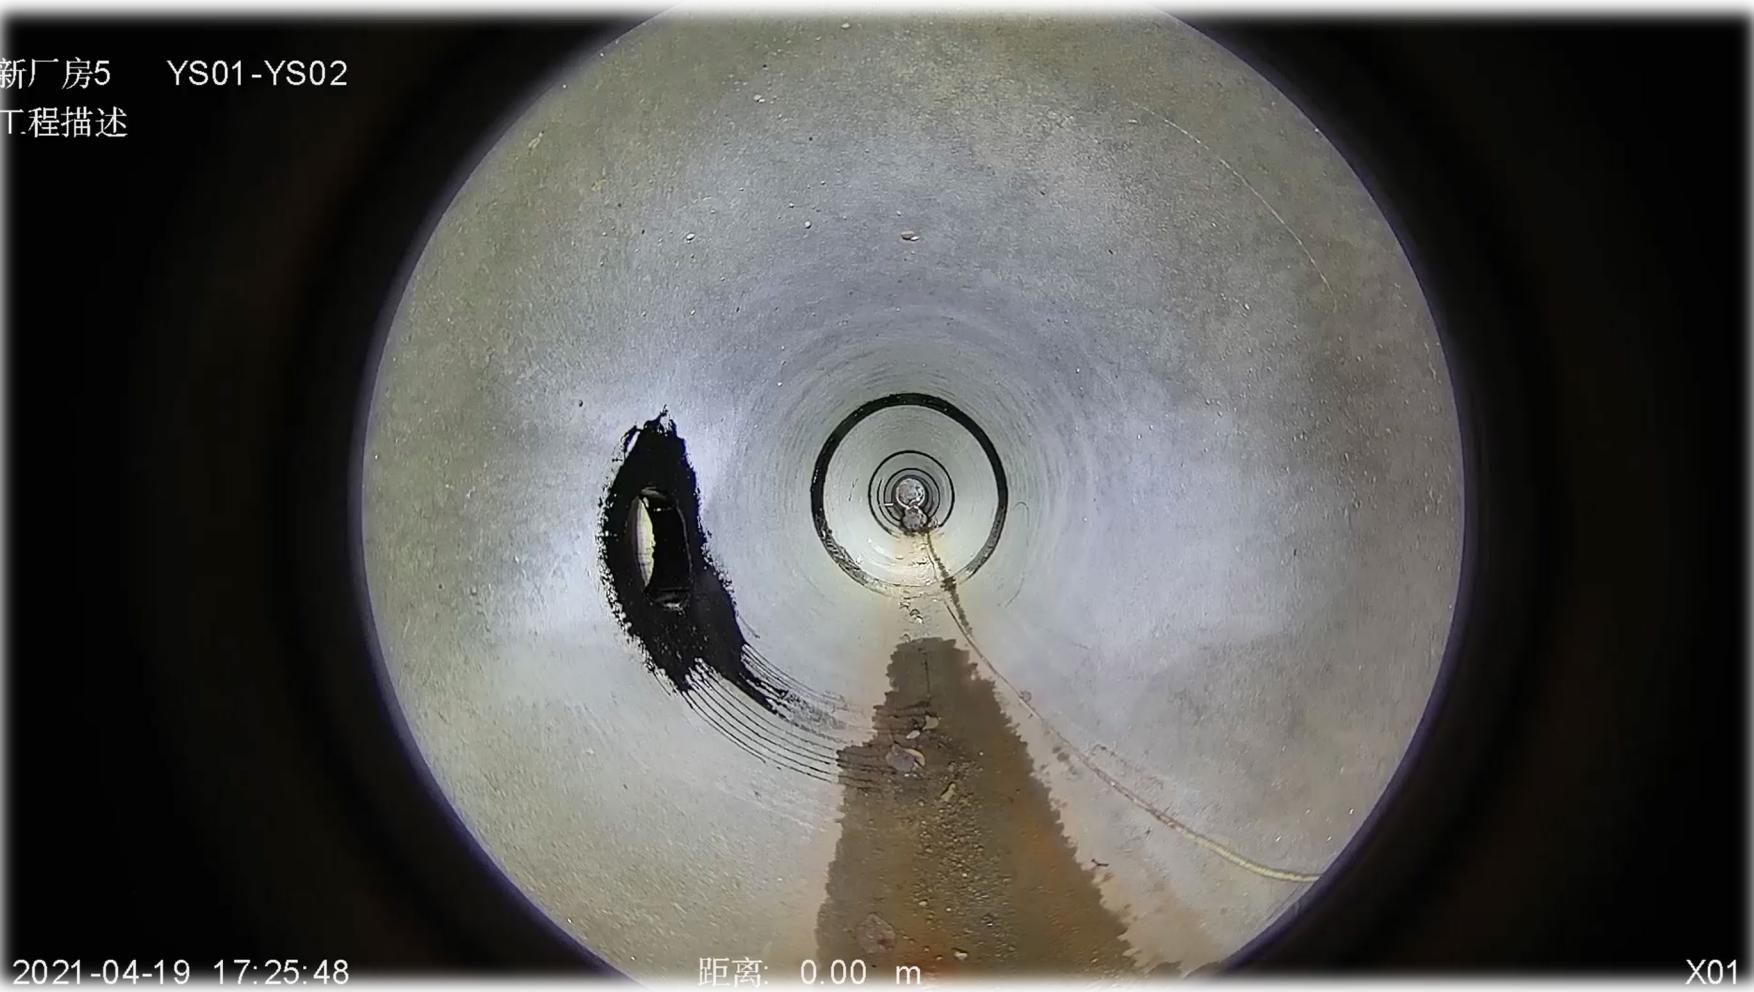
Video display

**Inspection process:**  
complete the whole process  
in one time, no need for  
operator monitoring:

- Non-stop
- No rotation
- No Look Around
- No zoom and focus
- No need to stop for observation

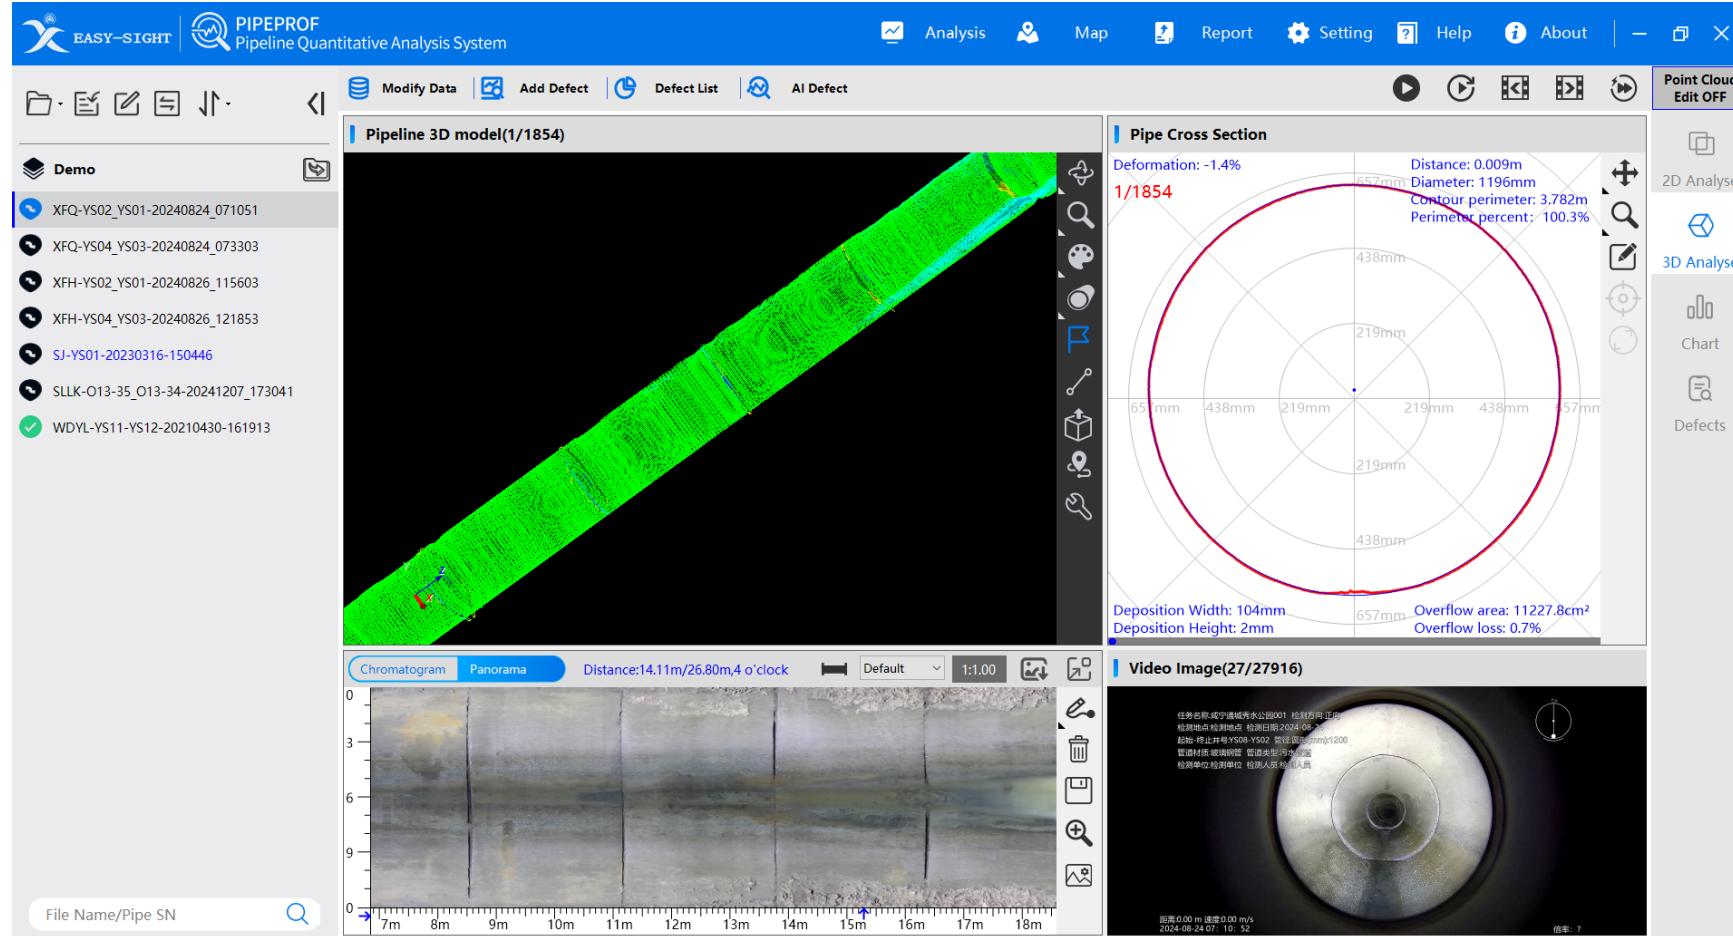
**Synchronous analysis of lidar, panoramic, video, IMU and other data.**

- Lidar profile, chromatogram, panorama, video linkage analysis
- Automatic calculation of defect size
- Intuitive and simple interpretation

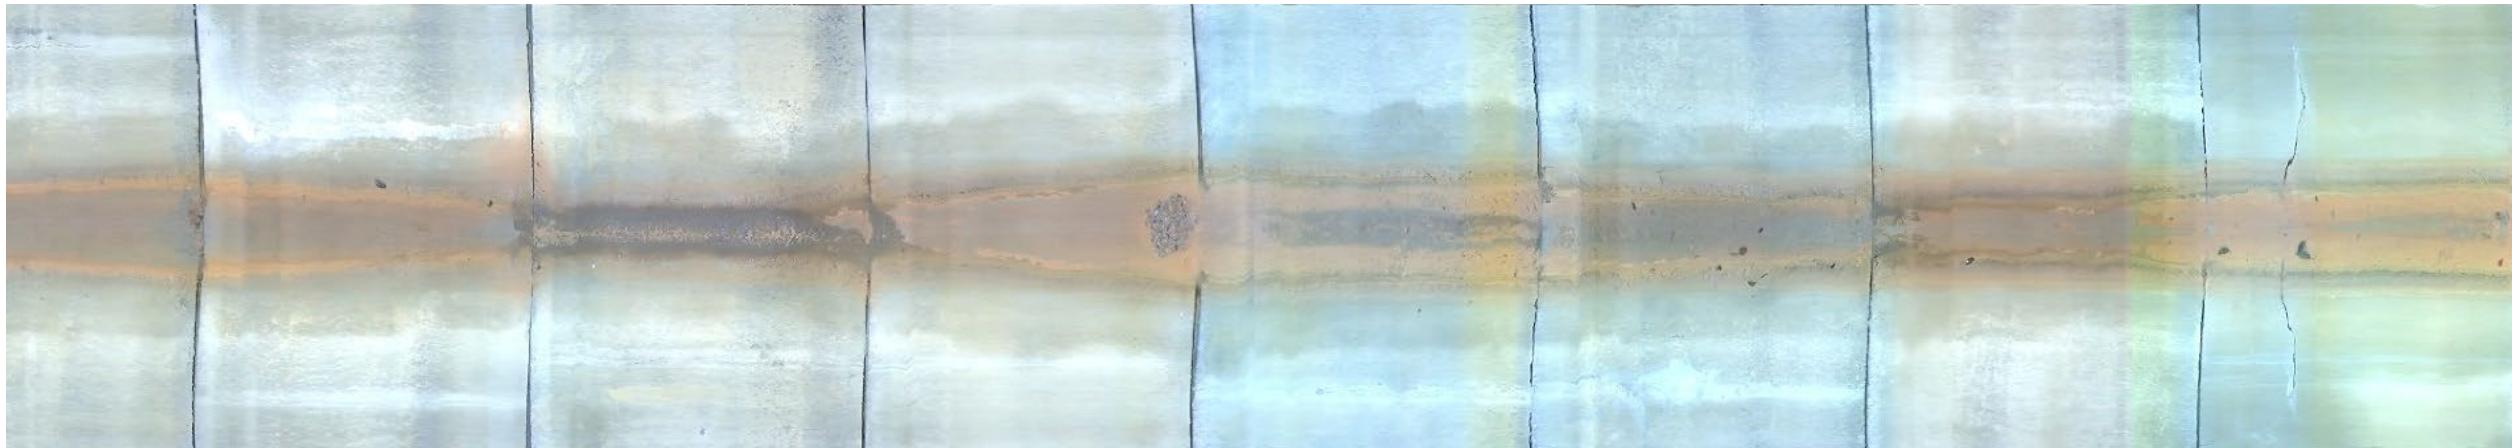
The above picture is a panoramic view of the inside of the pipeline obtained using panoramic quantitative detection technology, which is equivalent to cutting the pipeline open and then laying it flat. From the above picture, you can clearly see the deposits on the bottom of the pipe, cracks on the pipe wall, etc.

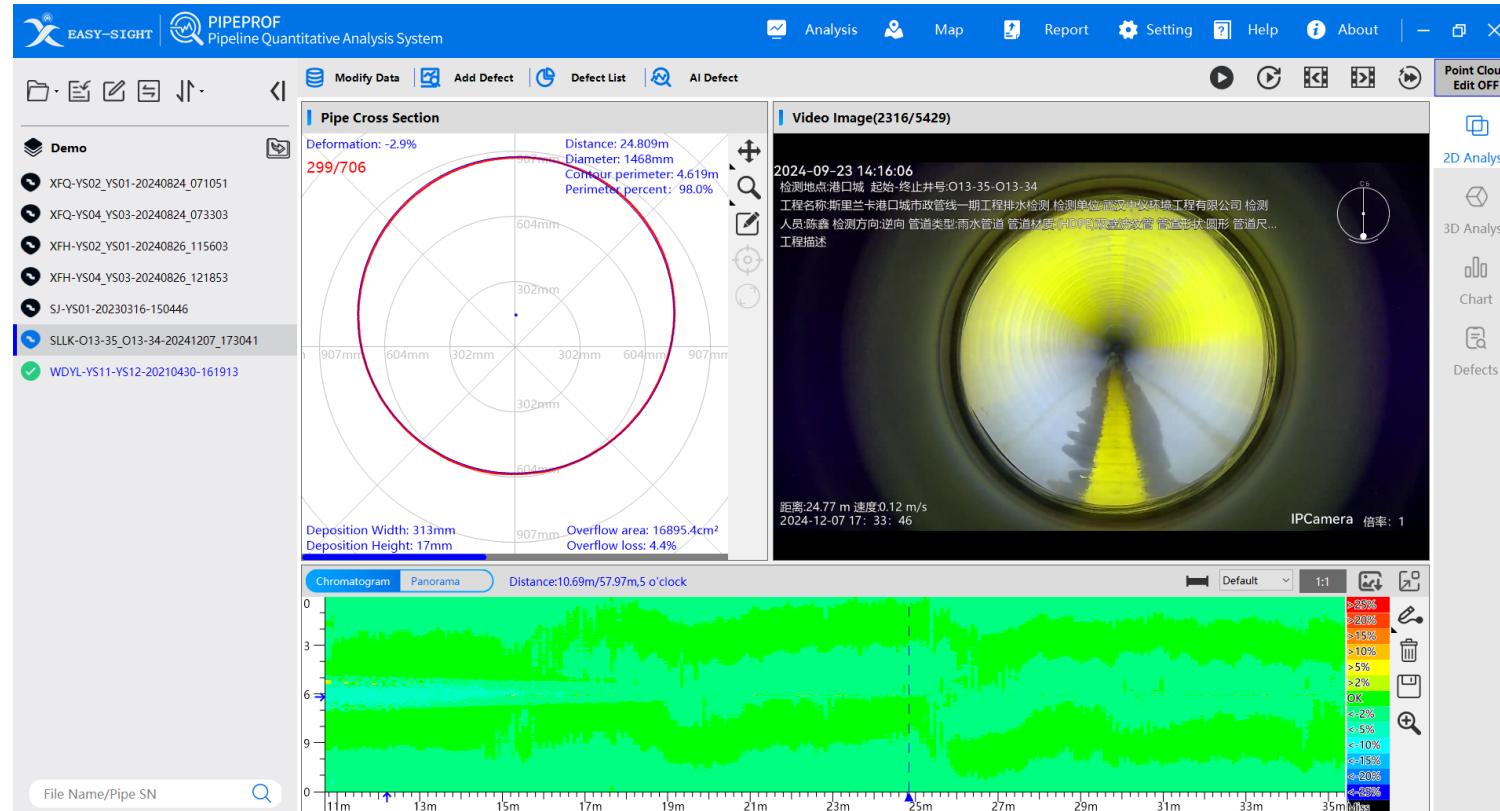
◎ Through the conditions set by the user, the defects are automatically judged according to the chromatogram expansion diagram, panoramic diagram, etc., and the automatic identification of various defects is supported.

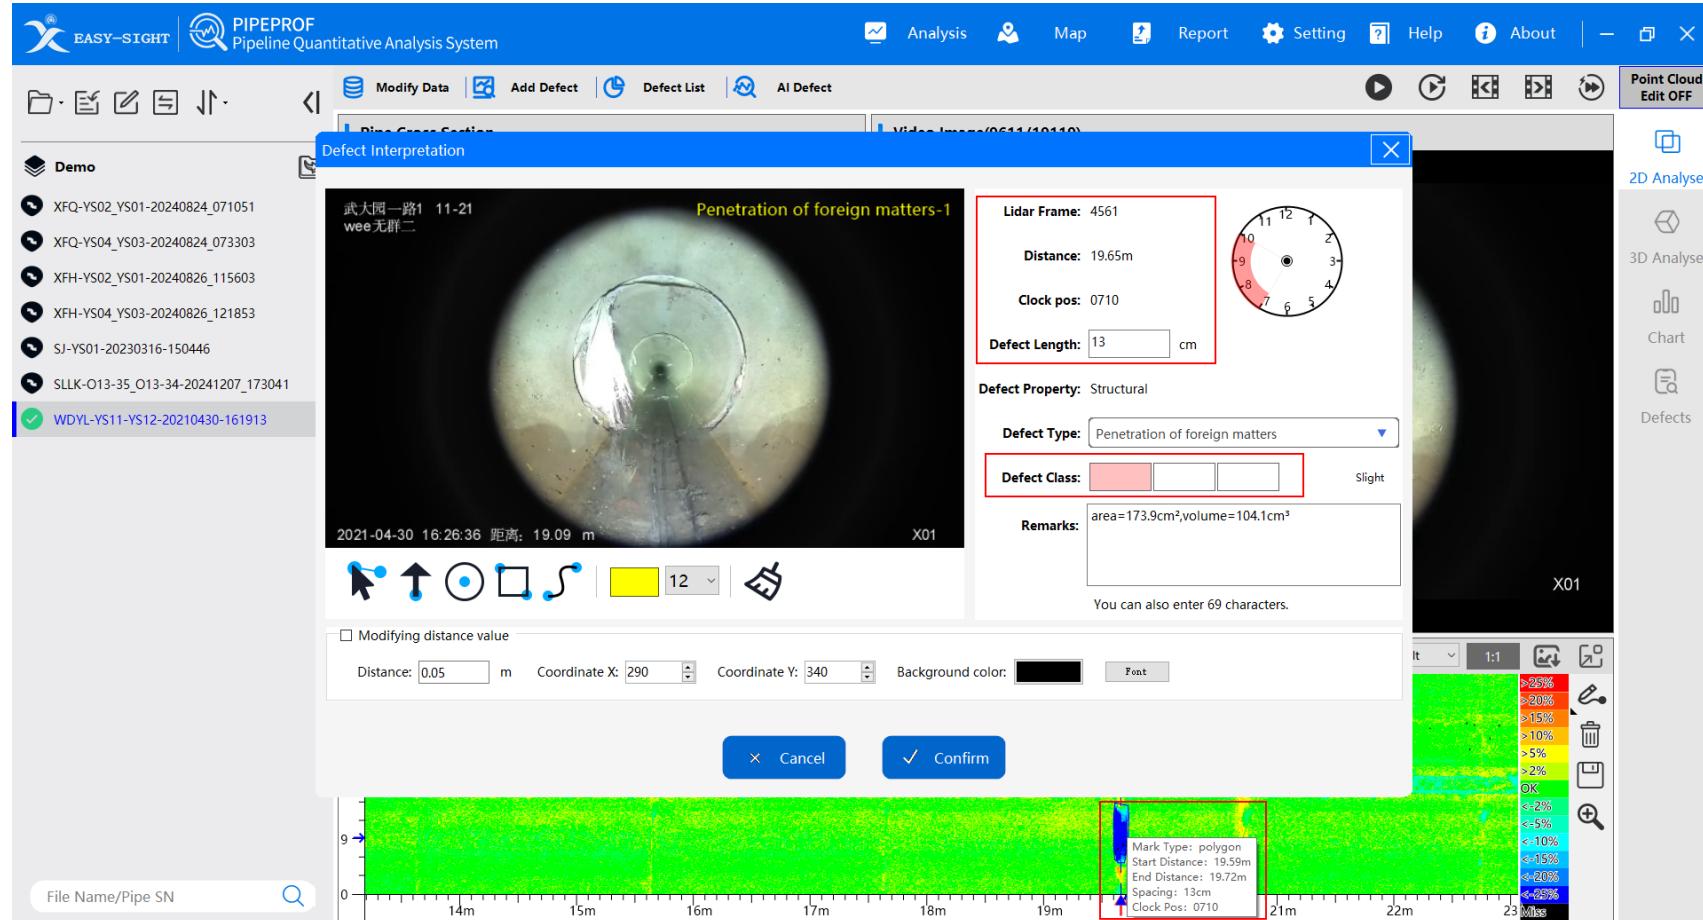
◎ Automatic quantification (area, volume, size)

◎ Automatic positioning (distance interval, time of day and time of day)

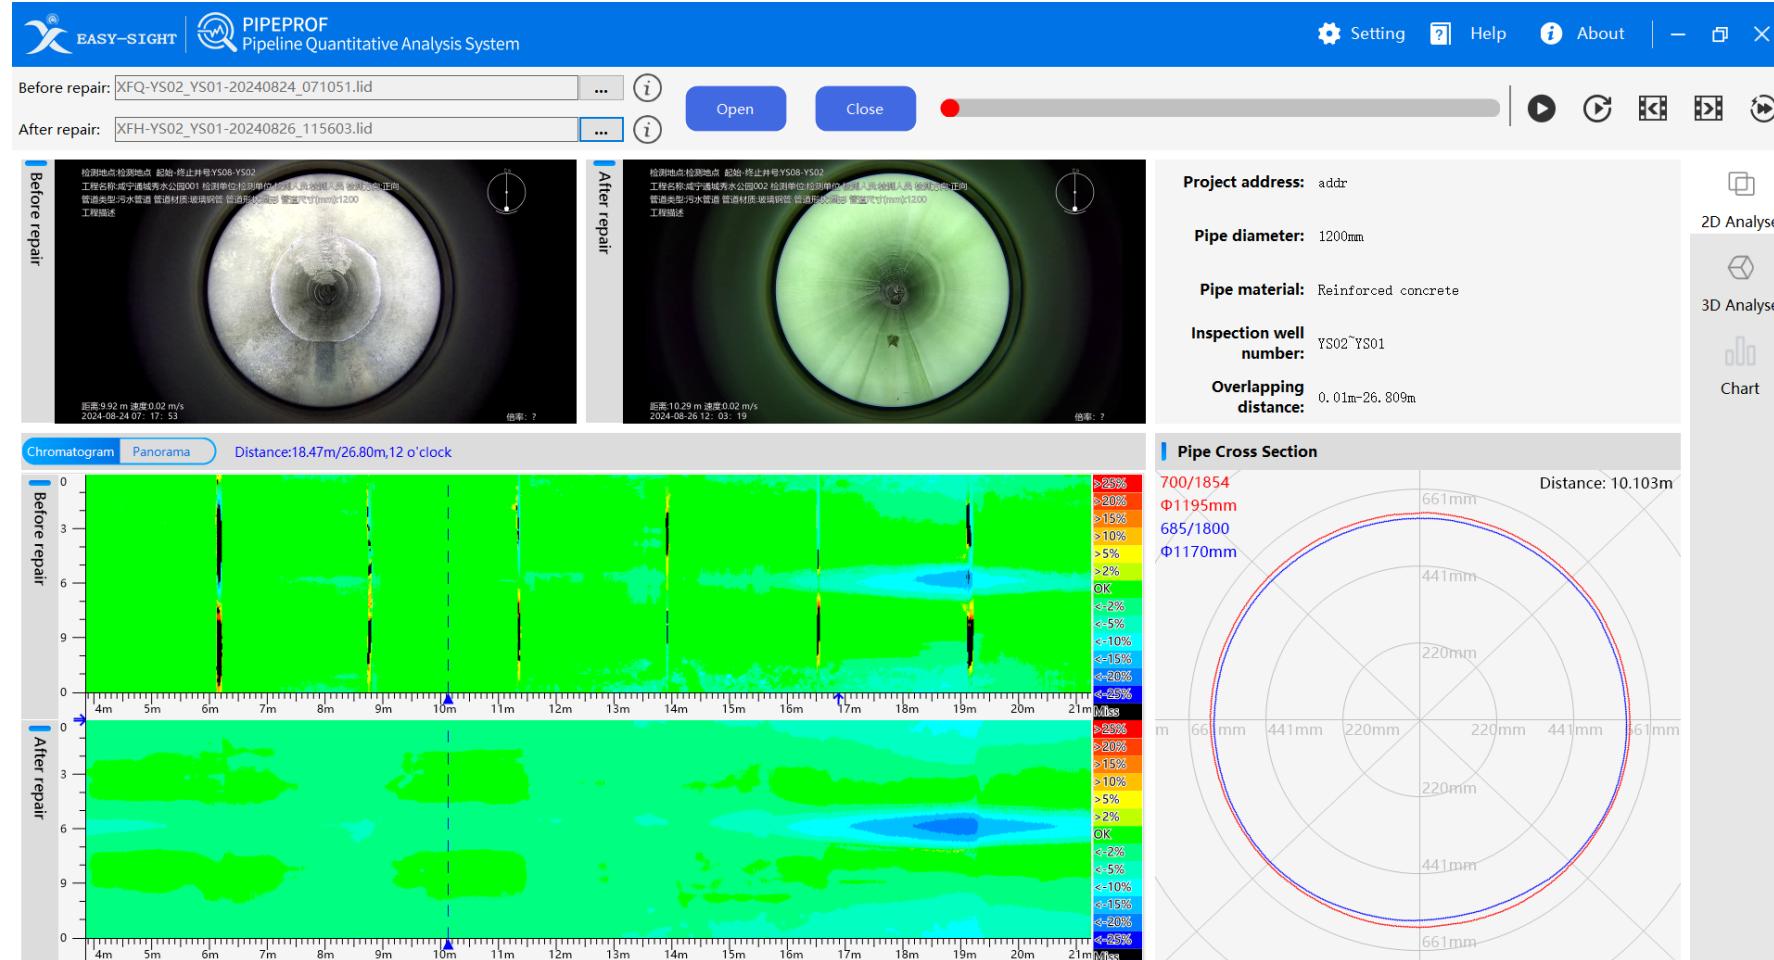
It can quickly view the video images before and after the pipeline repair, the pipeline chromatogram expansion diagram, the pipeline panoramic expansion diagram, and the comparison diagram of the lidar cross-section profile. It can accurately measure the thickness of the repair material.

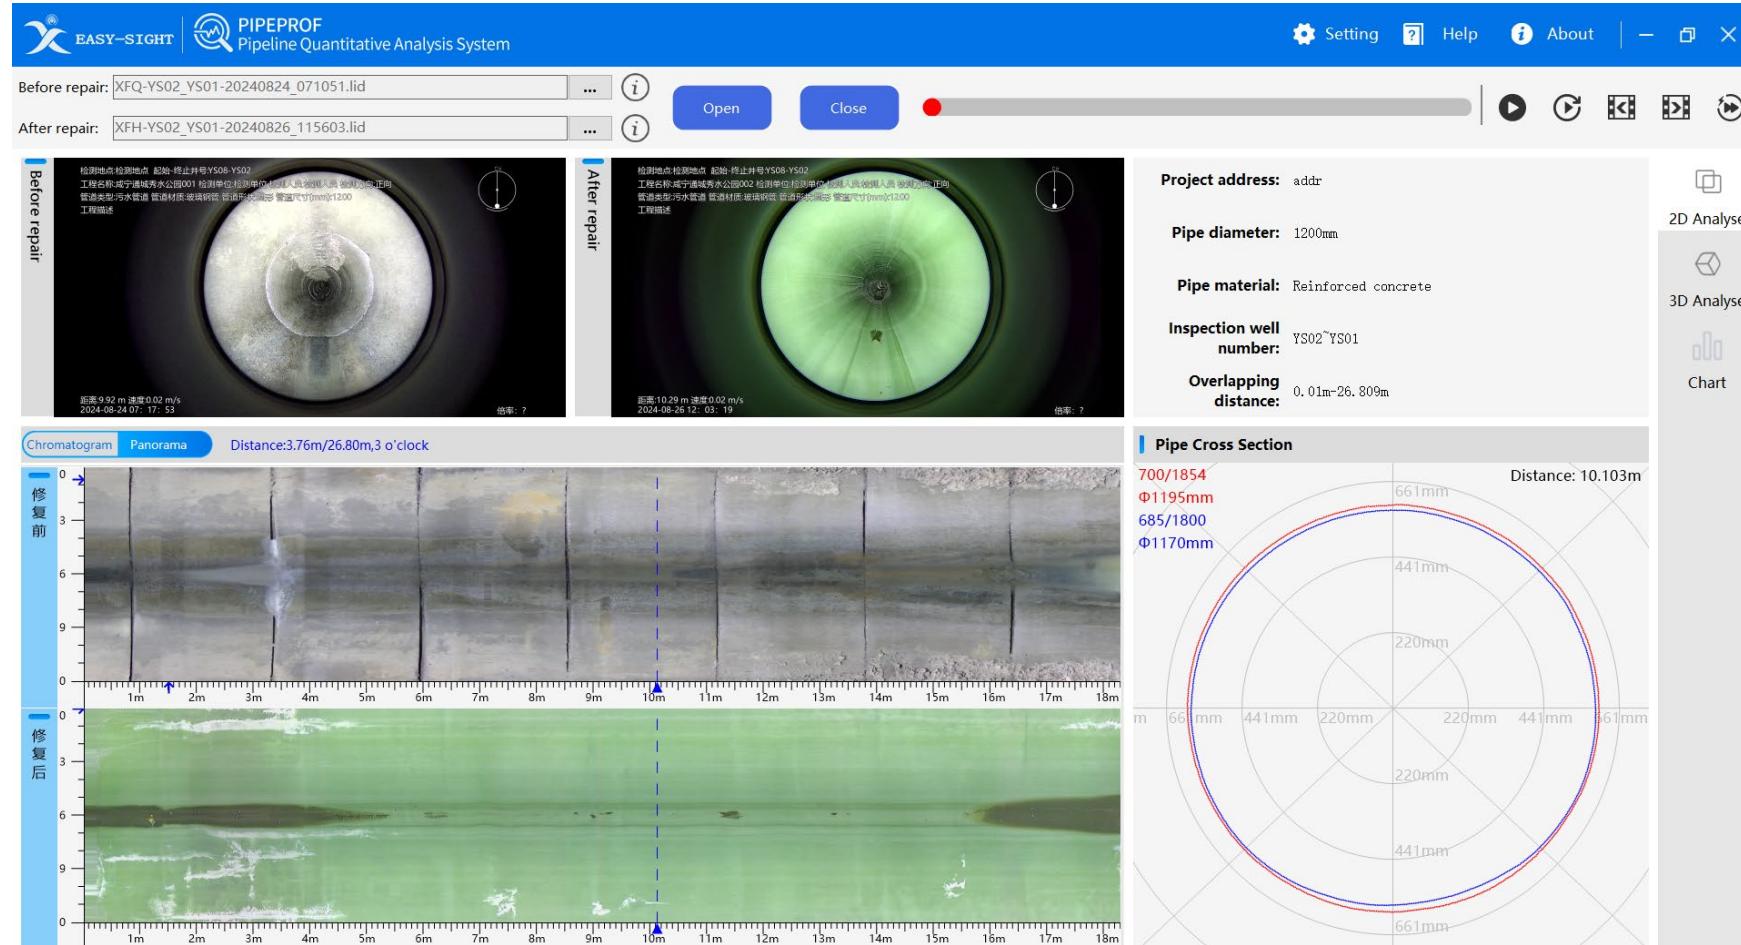
It can quickly view the video images before and after the pipeline repair, the pipeline chromatogram expansion diagram, the pipeline panoramic expansion diagram, and the comparison diagram of the laser cross-section profile. It can accurately measure the thickness of the repair material.

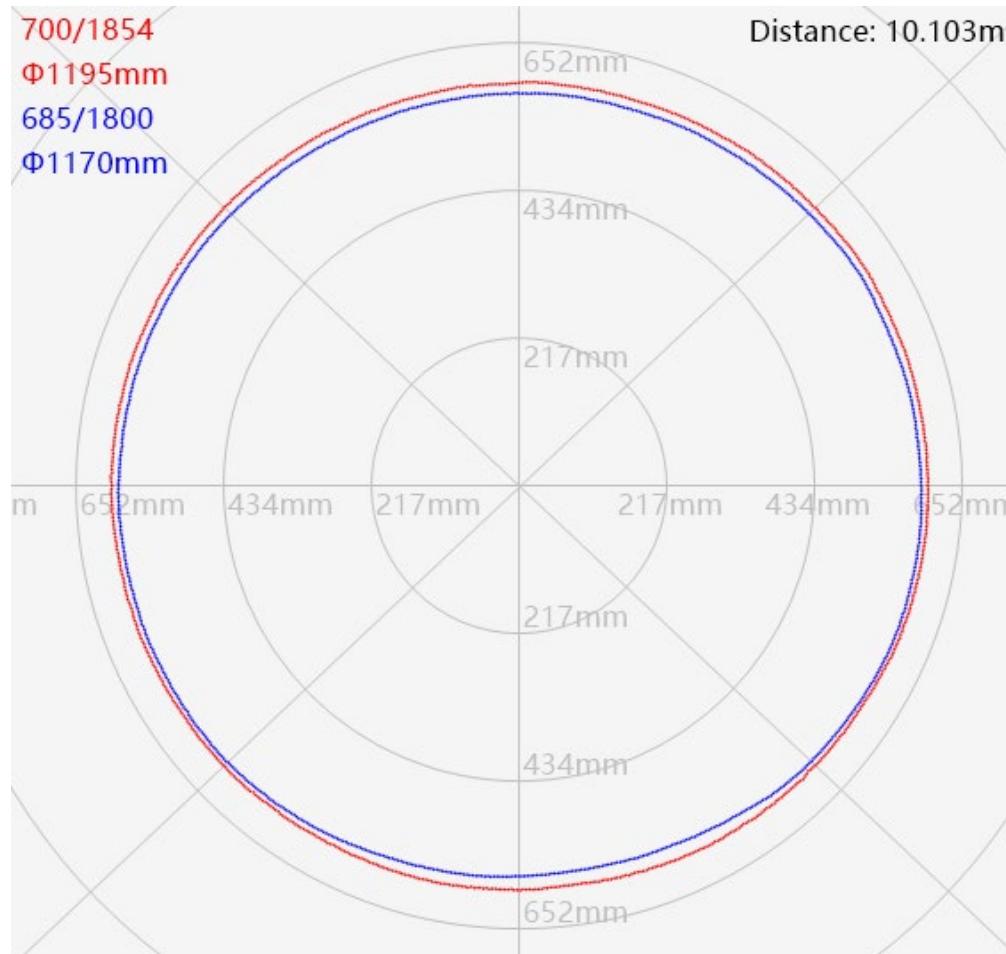
### ➤ 2D analysis - single frame profile comparison

The red part is the point cloud of the pipeline contour before repair, and the blue part is the point cloud of the pipeline contour after repair.

The distance difference at any clock position can be measured to calculate the wall thickness.

Each frame contour (one frame corresponds to one distance point) can be analyzed.
