# Pipeline High Accuracy Detection Technology

## Panoramic Quantitative Robot

Wuhan Easy Sight Technology Co.,Ltd.

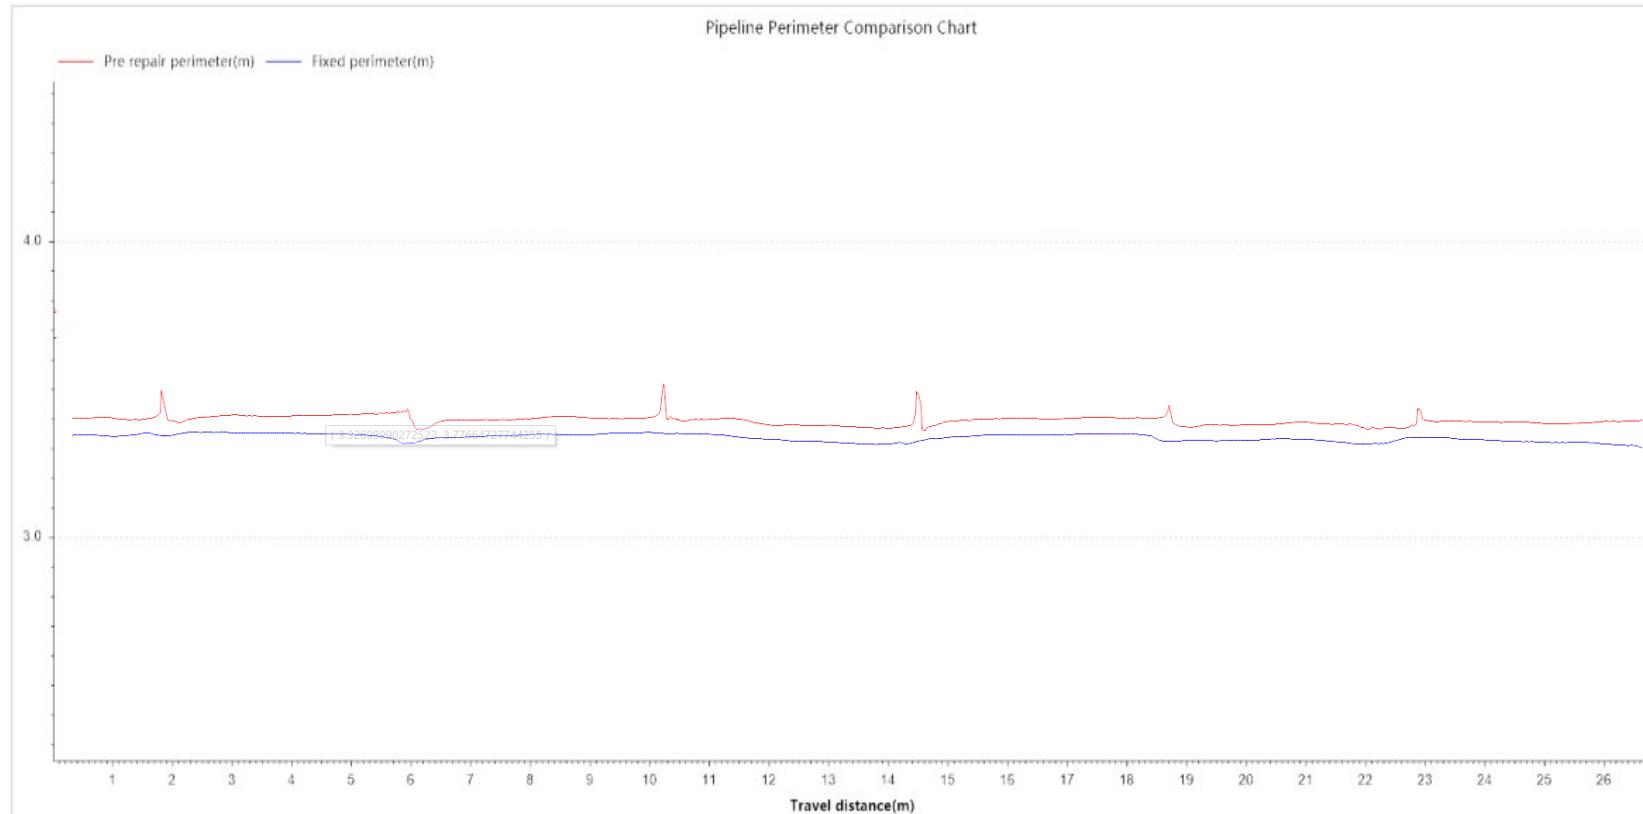
Comparative analysis is performed from multiple aspects, including the **pipeline contour circumference diagram** before and after repair, pipeline wall thickness change diagram, pipeline contour expansion comparison diagram, etc.

The value interval can be set arbitrarily.

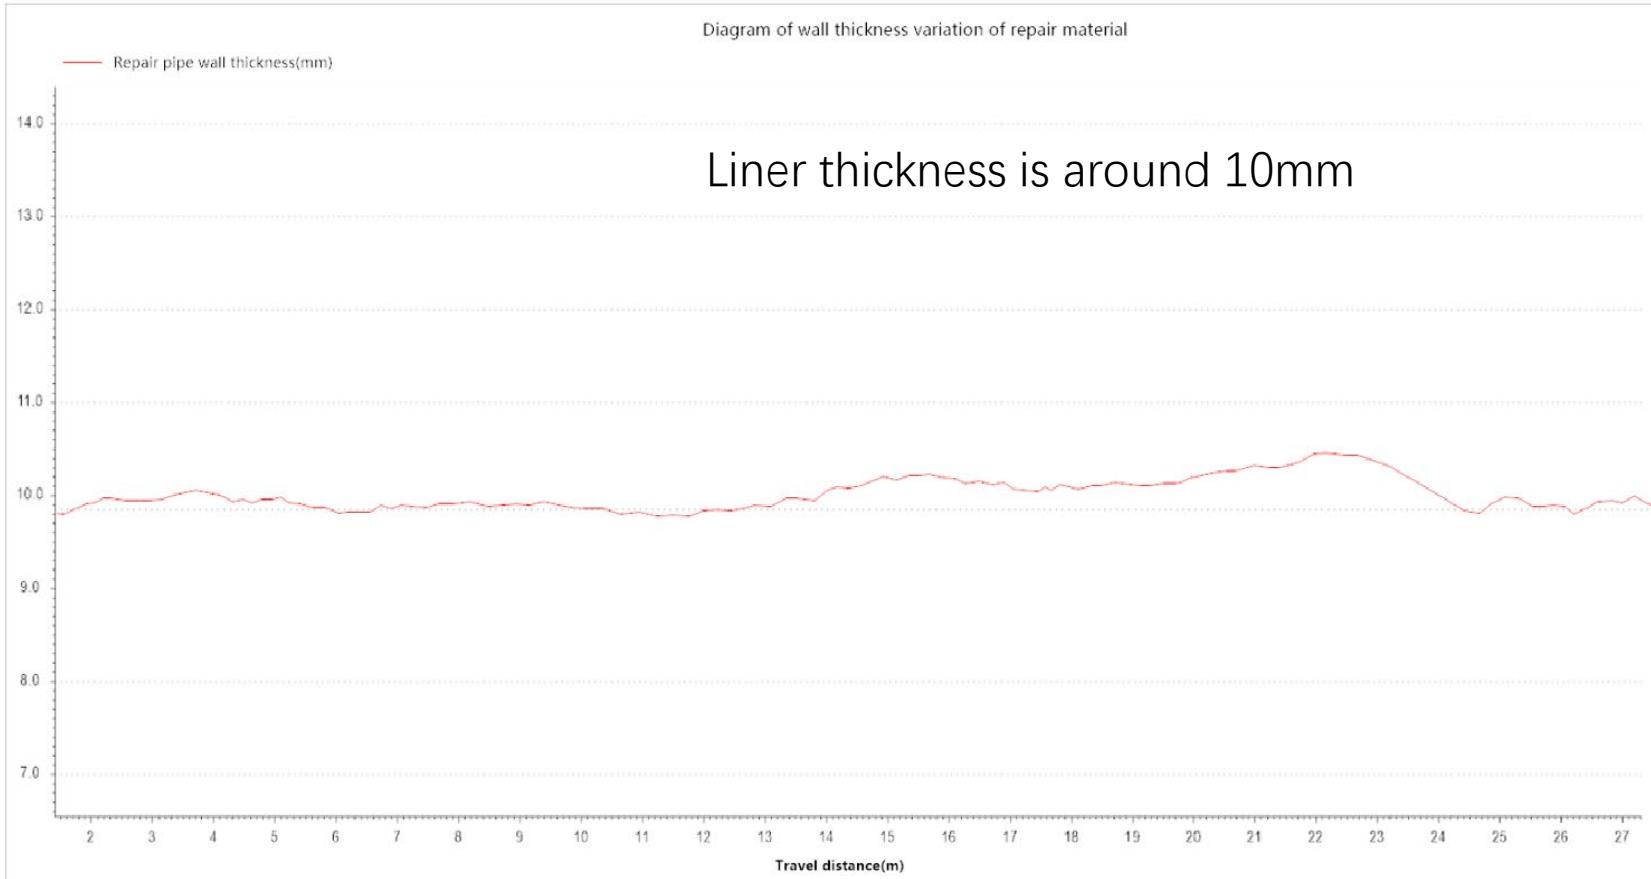
Comparative analysis is performed from multiple aspects, including the **pipeline contour circumference diagram before and after repair**, **pipeline wall thickness change diagram**, **pipeline contour expansion comparison diagram**, etc. The value interval can be set arbitrarily.

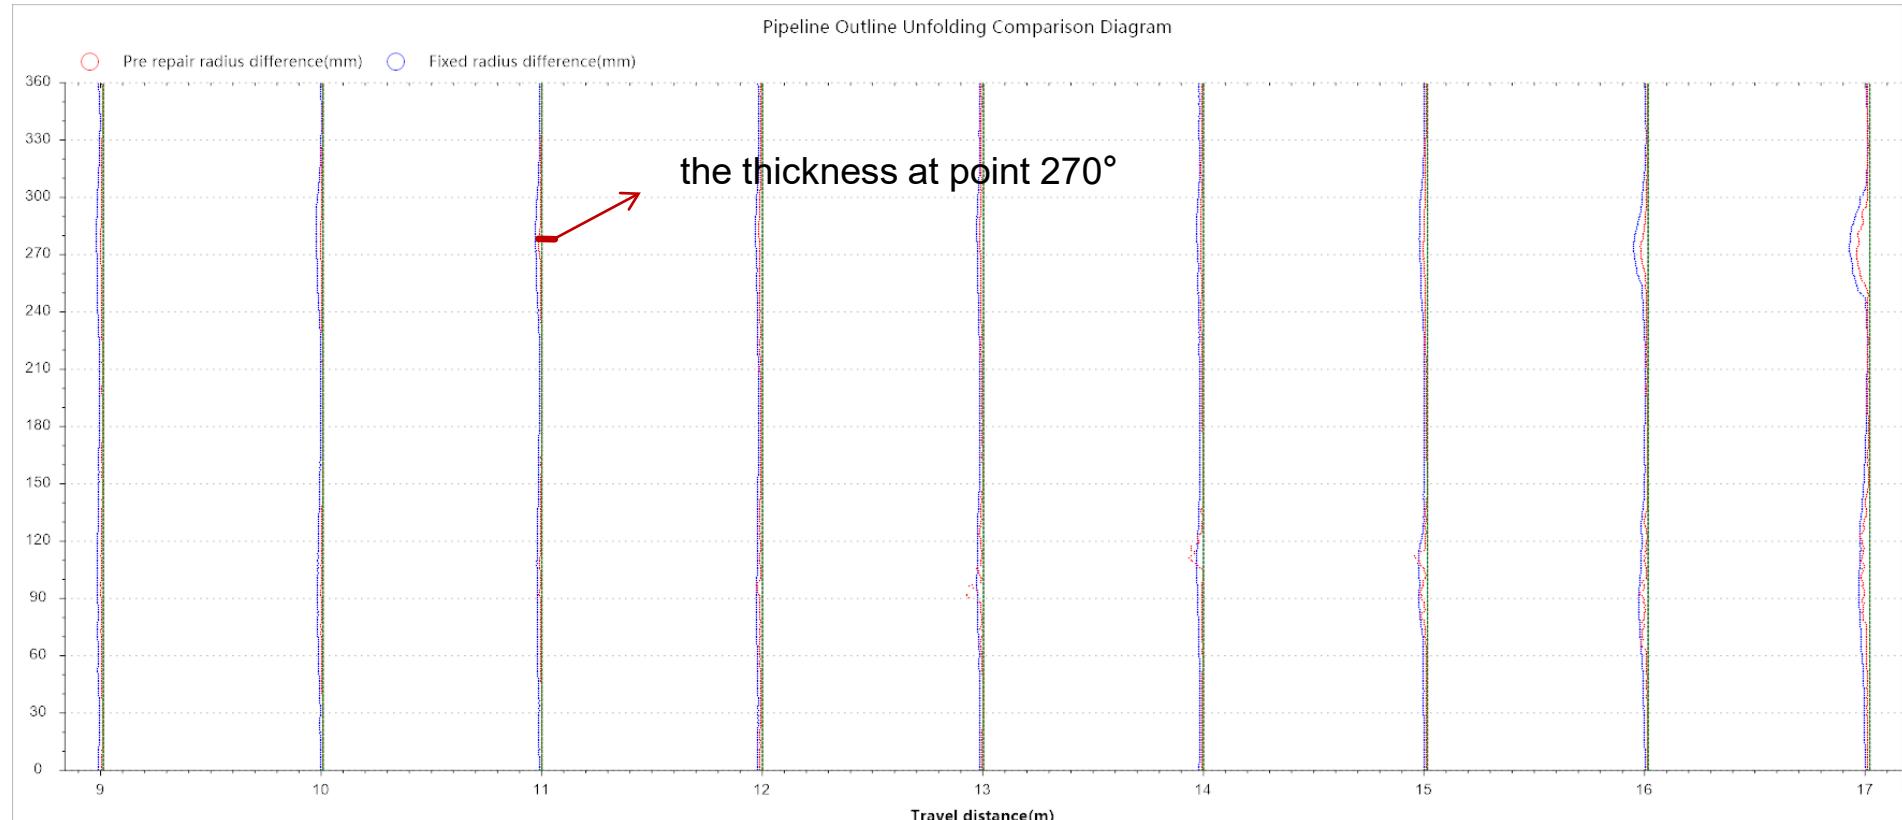
Comparative analysis is performed from multiple aspects, including the pipeline contour circumference diagram before and after repair, **pipeline wall thickness change diagram**, pipeline contour expansion comparison diagram, etc. The value interval can be set arbitrarily.

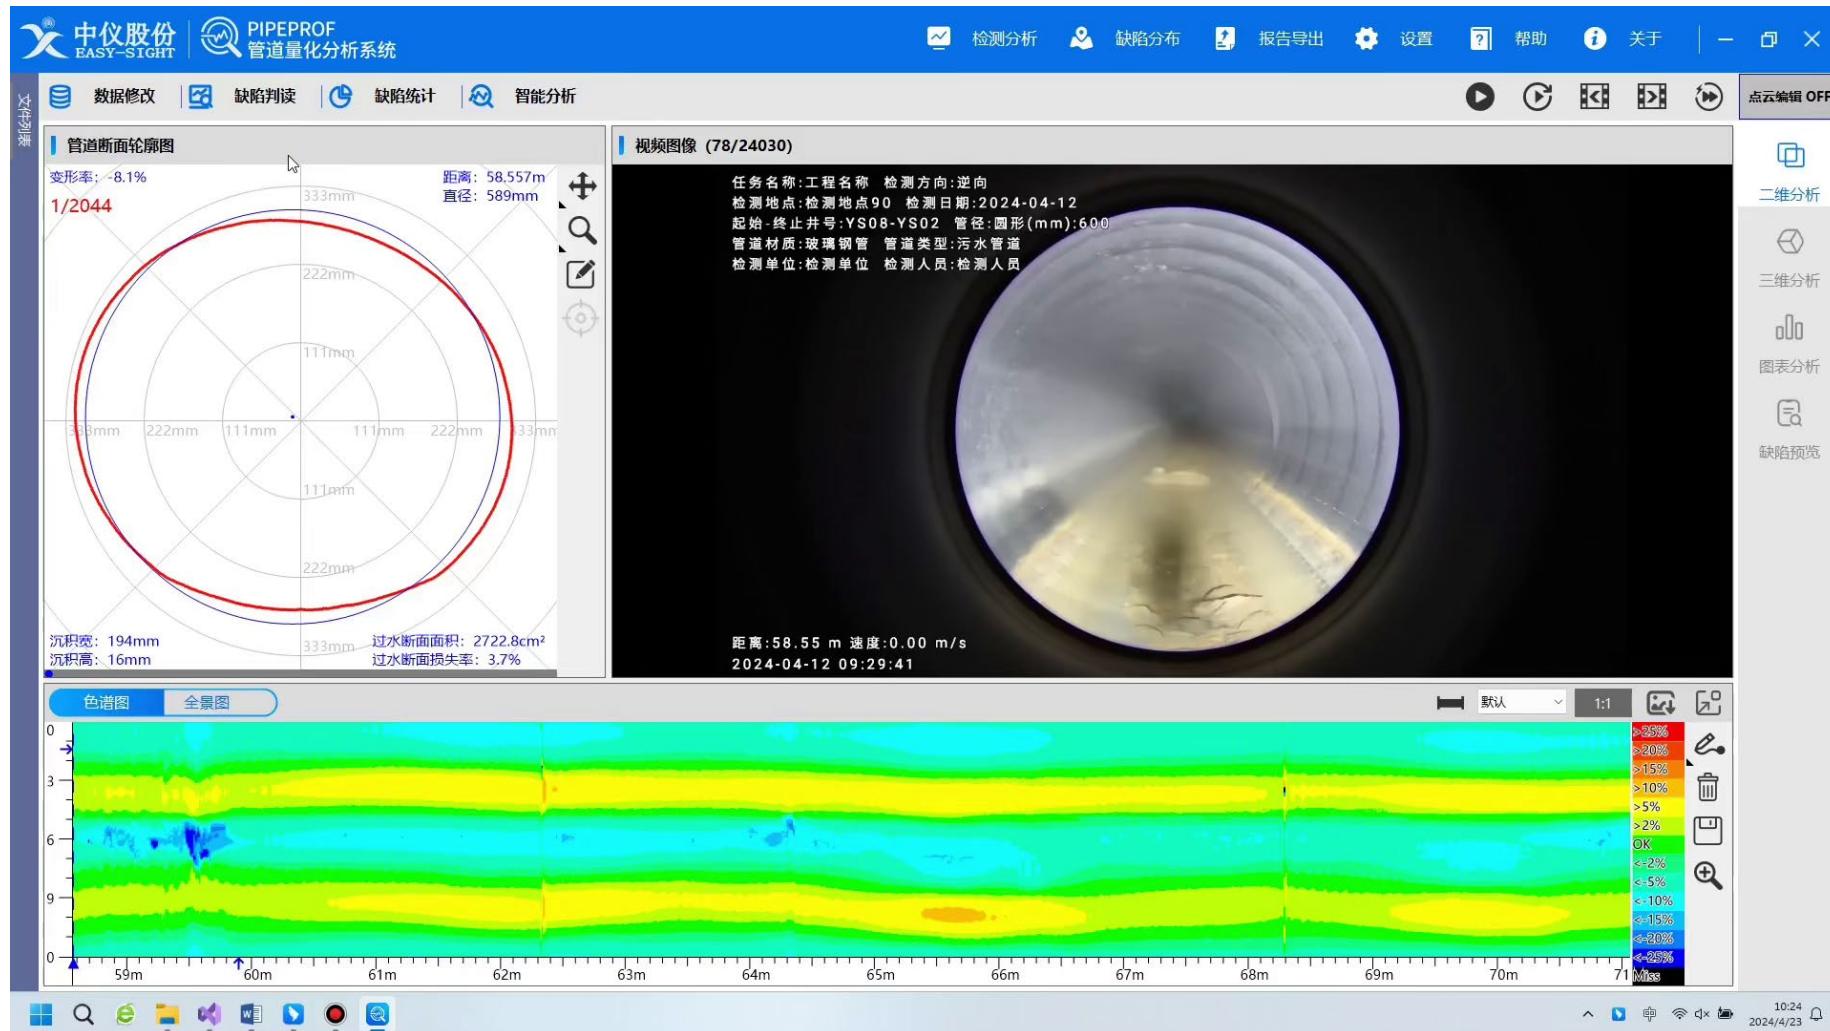
# 3D Model

Result output

video display

● Support 3D point cloud and real scene map display

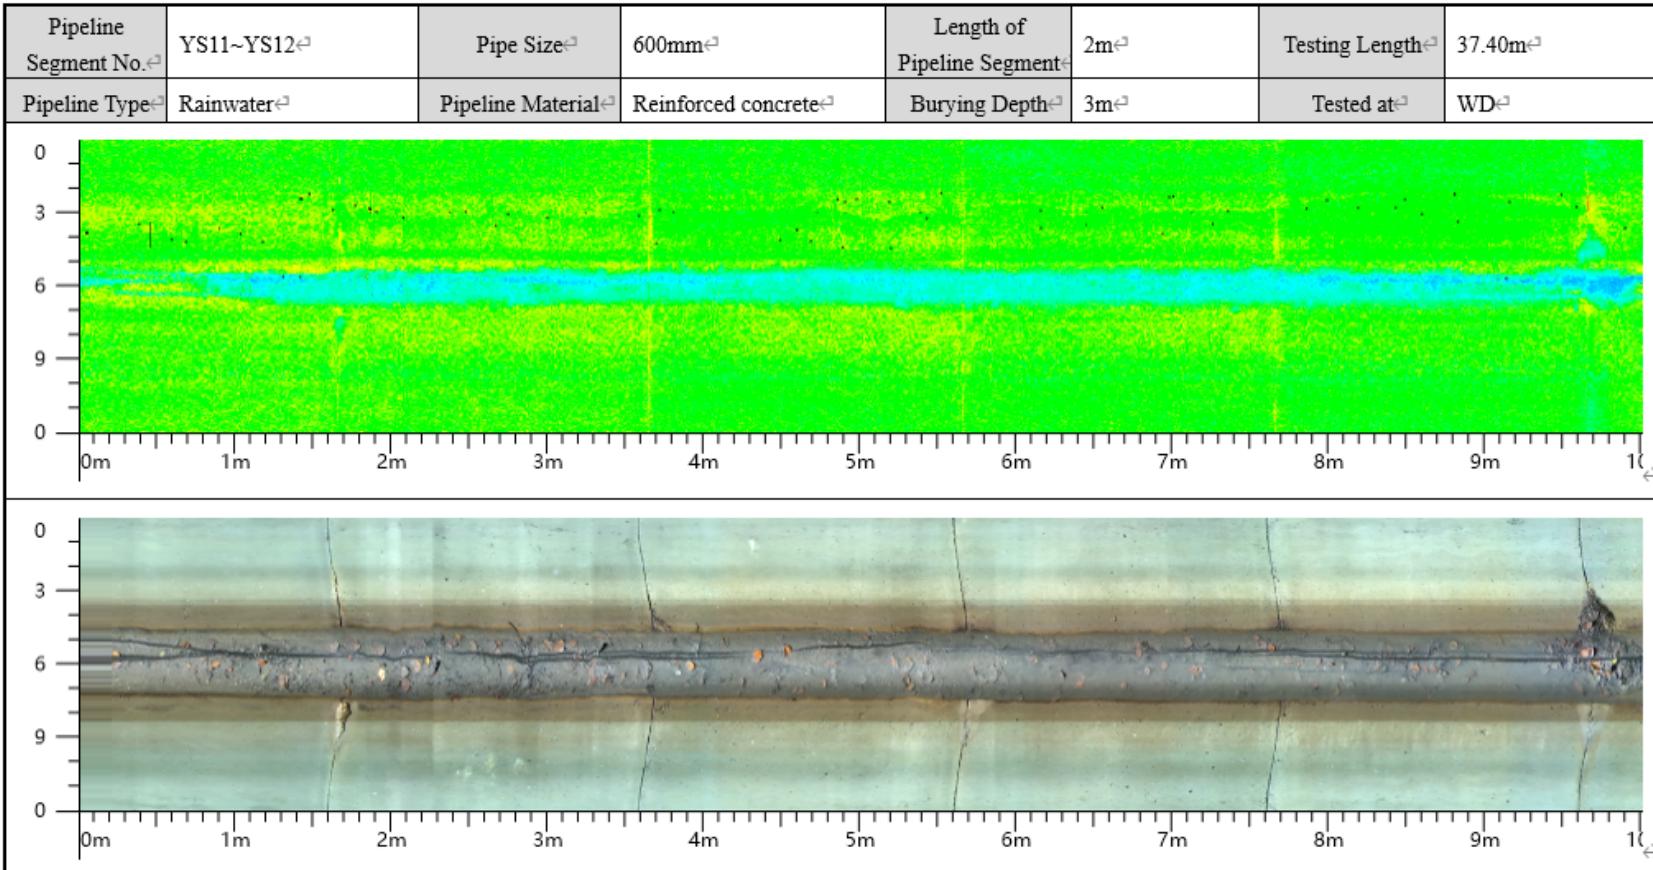
## ▪ 2.4 Pipeline Expanded View

Pipeline expansion diagram, intuitively showing the internal situation of the pipeline, blue indicates slight sediment

The above picture is a panoramic view of the inside of the pipeline obtained using panoramic quantitative detection technology, which is equivalent to cutting the pipeline open and then laying it flat. From the above picture, you can clearly see the deposits on the bottom of the pipe, cracks on the pipe wall, etc.

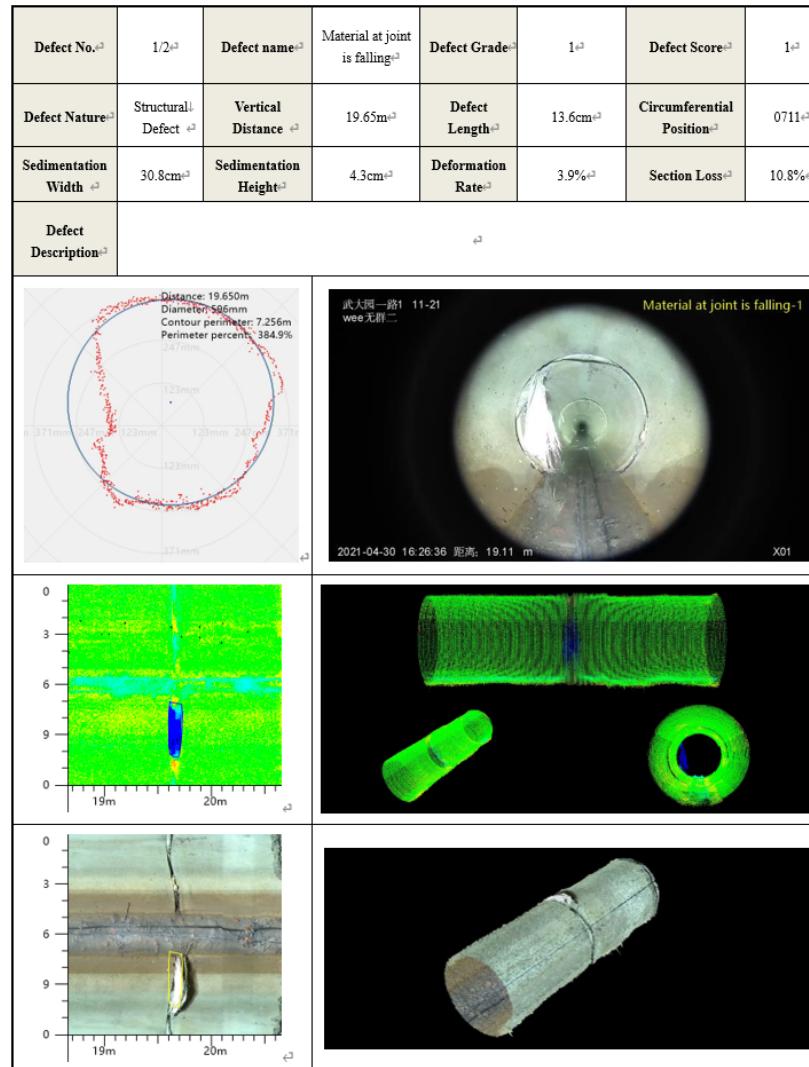
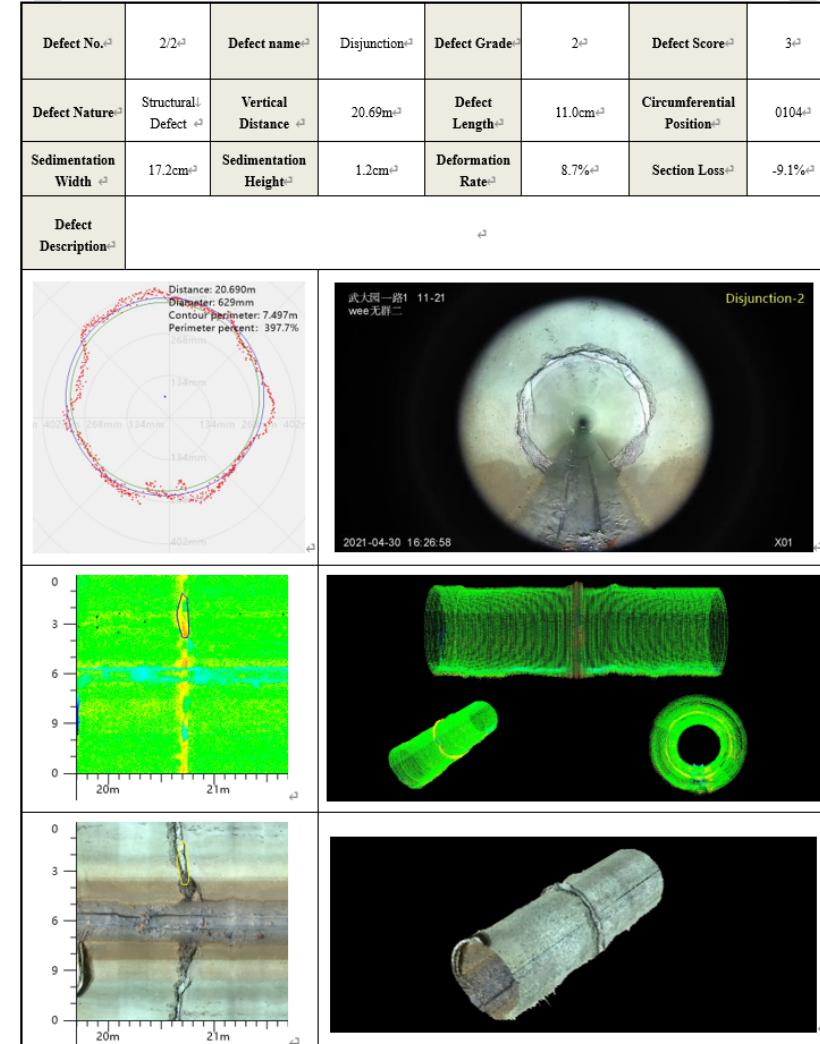
# Comprehensive presentation of defects

showing defects from multiple angles

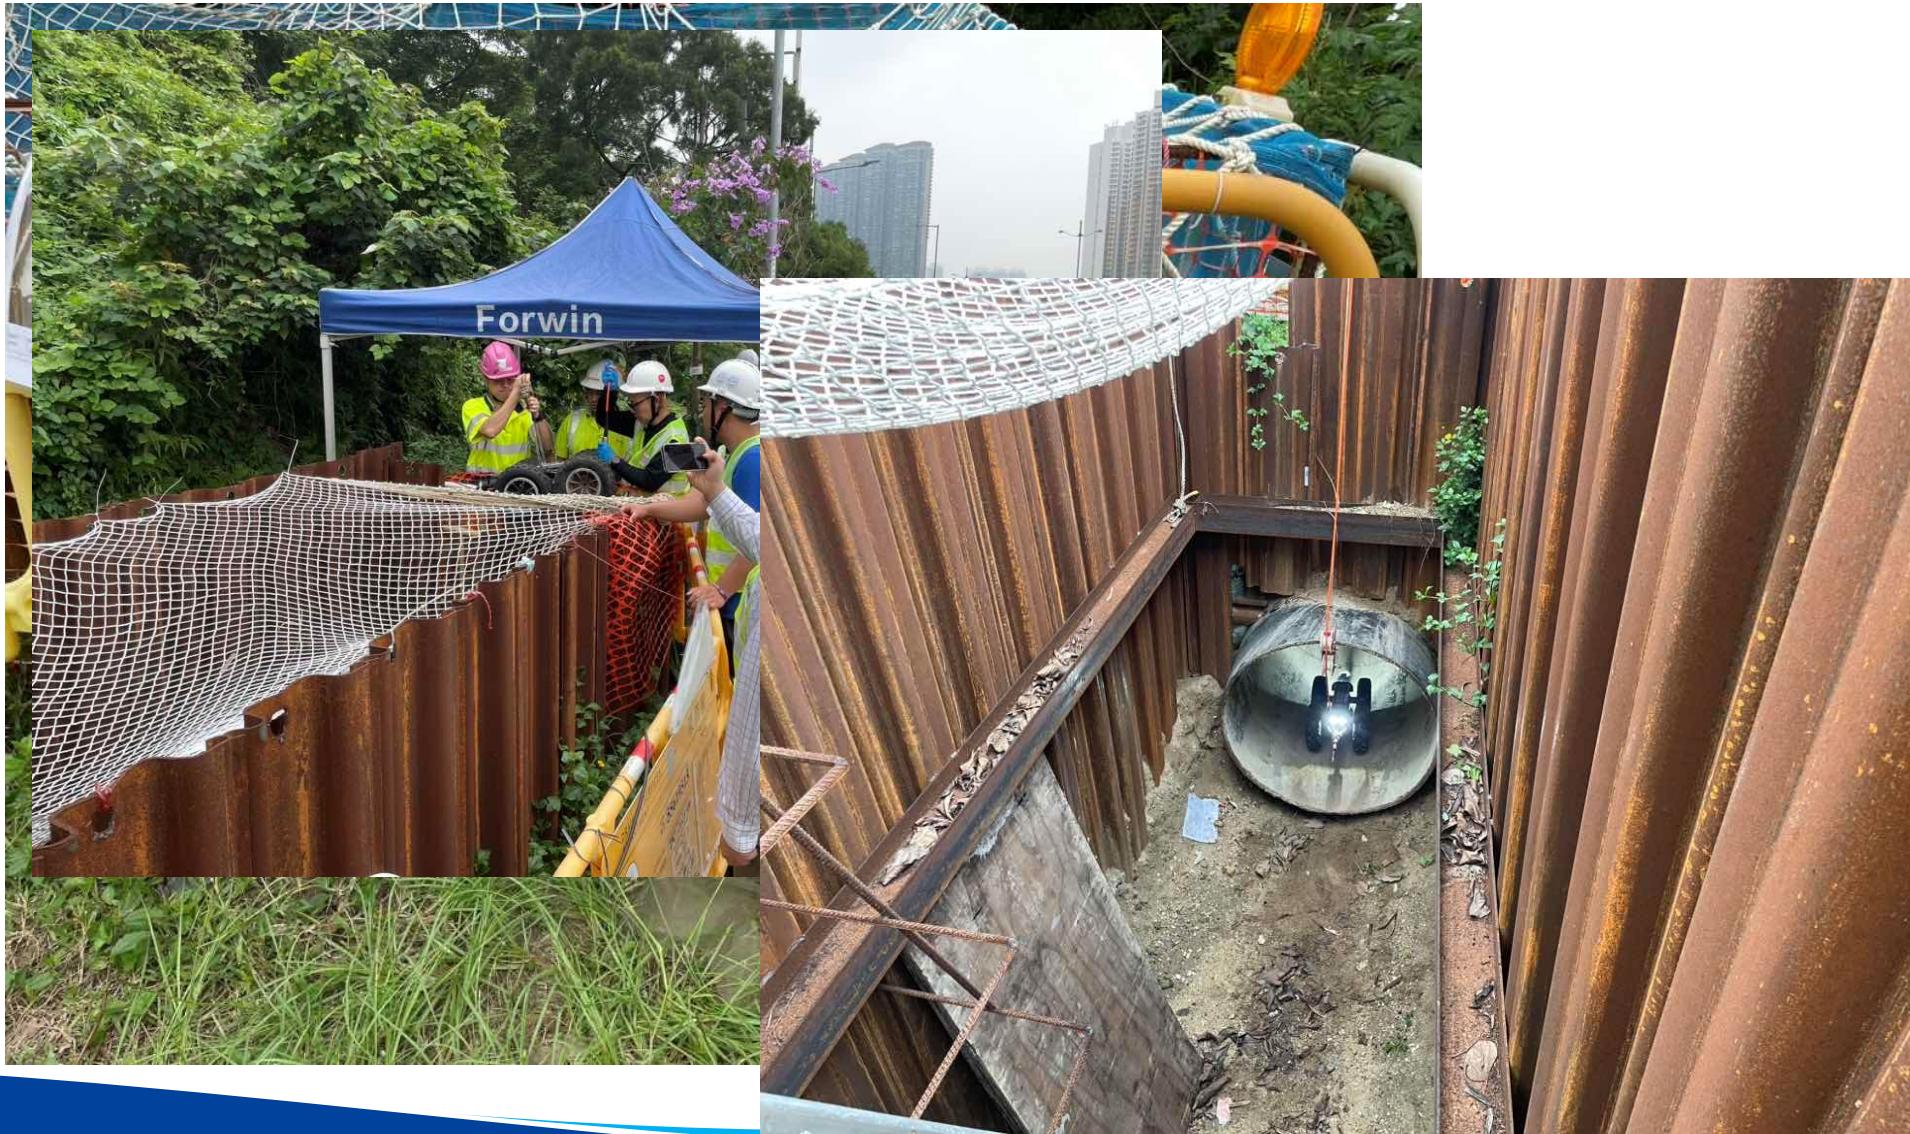
Hongkong

The Drainage Services Department of Hong Kong needs to repair a pressurized sewage pipe with a length of about 6KM and a pipe diameter of DN1200. Customized liner is difficult!!

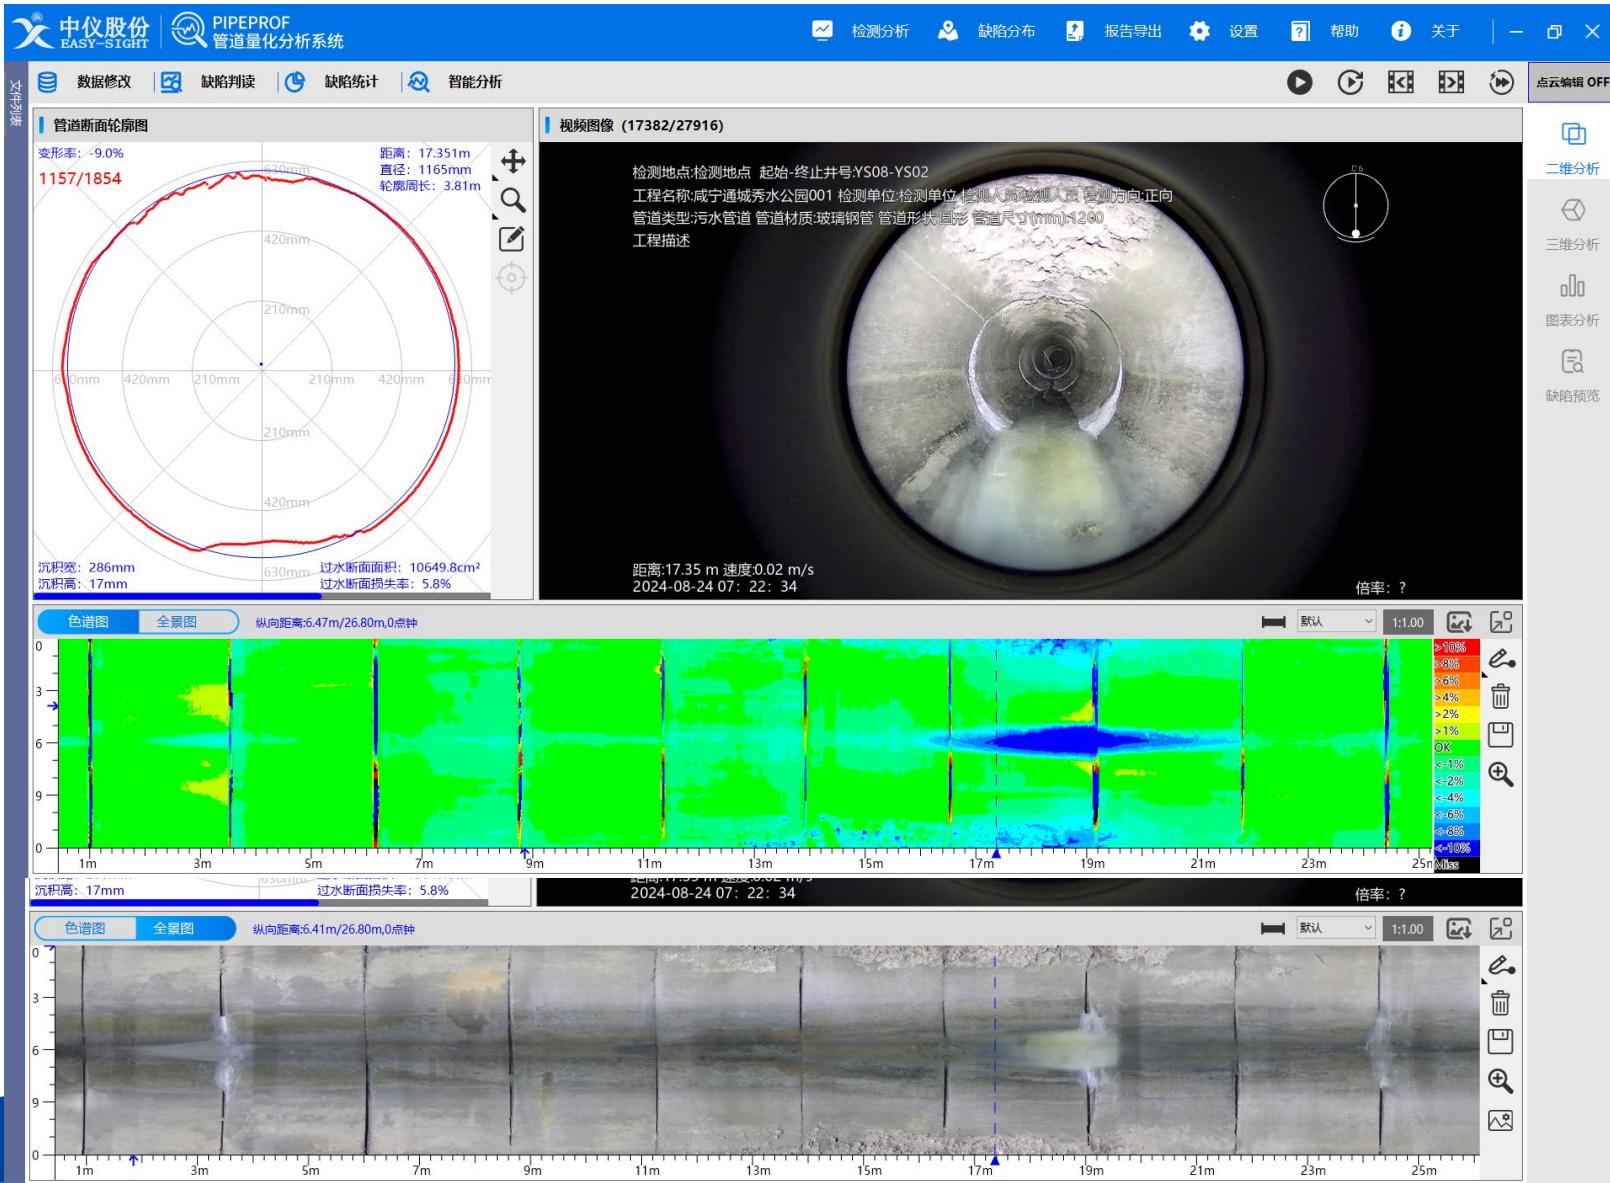
Xianning

In one park, the pipe diameter is DN1200 and the inspection length is 38m. The pipeline has obvious disconnection, undulation, scaling and other problems.

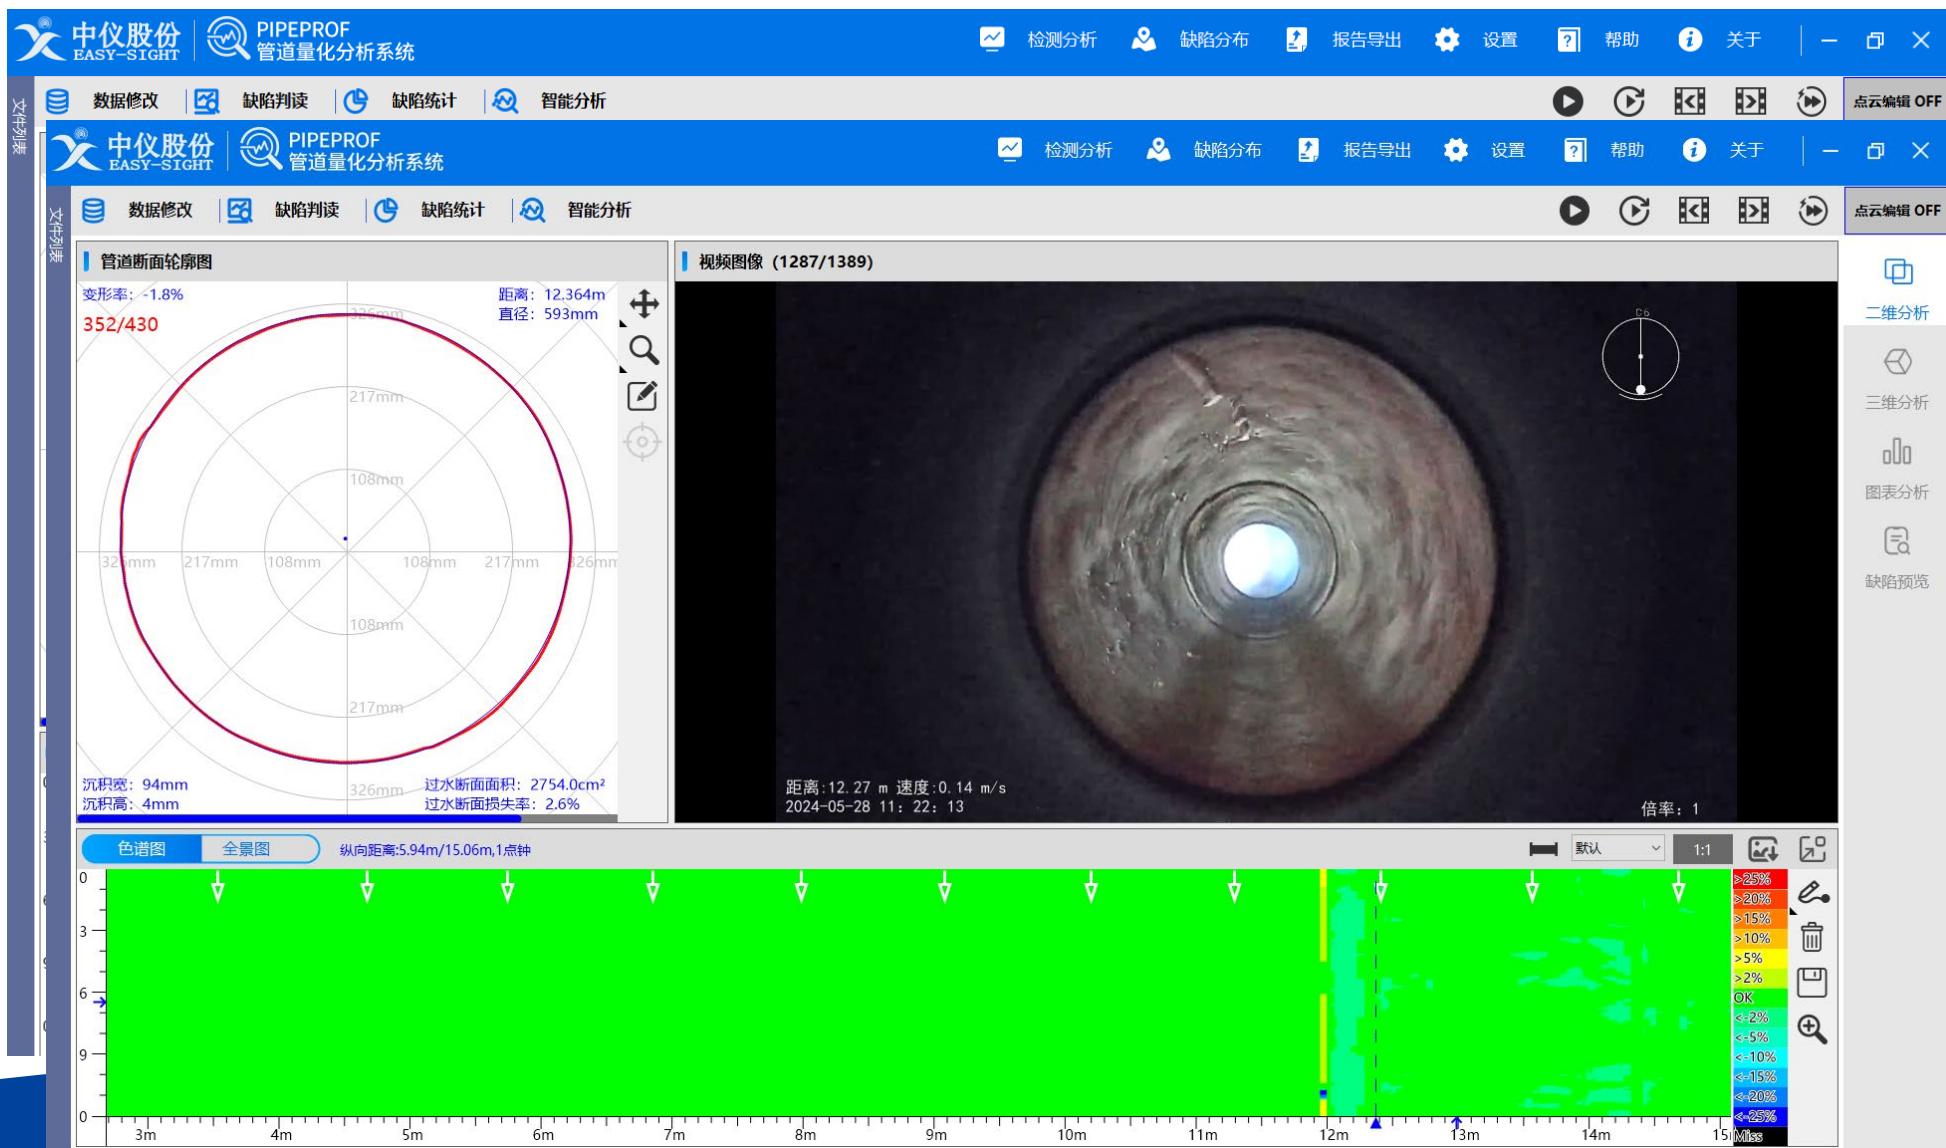
Xi' an

Lay a DN600 water supply pipeline, measure the change in the inner diameter of the pipeline, deformation rate, and other cleaning measures after laying. At 12m is the valve connection pipe, where you can see obvious scratches on the connection pipe and some distortion.。

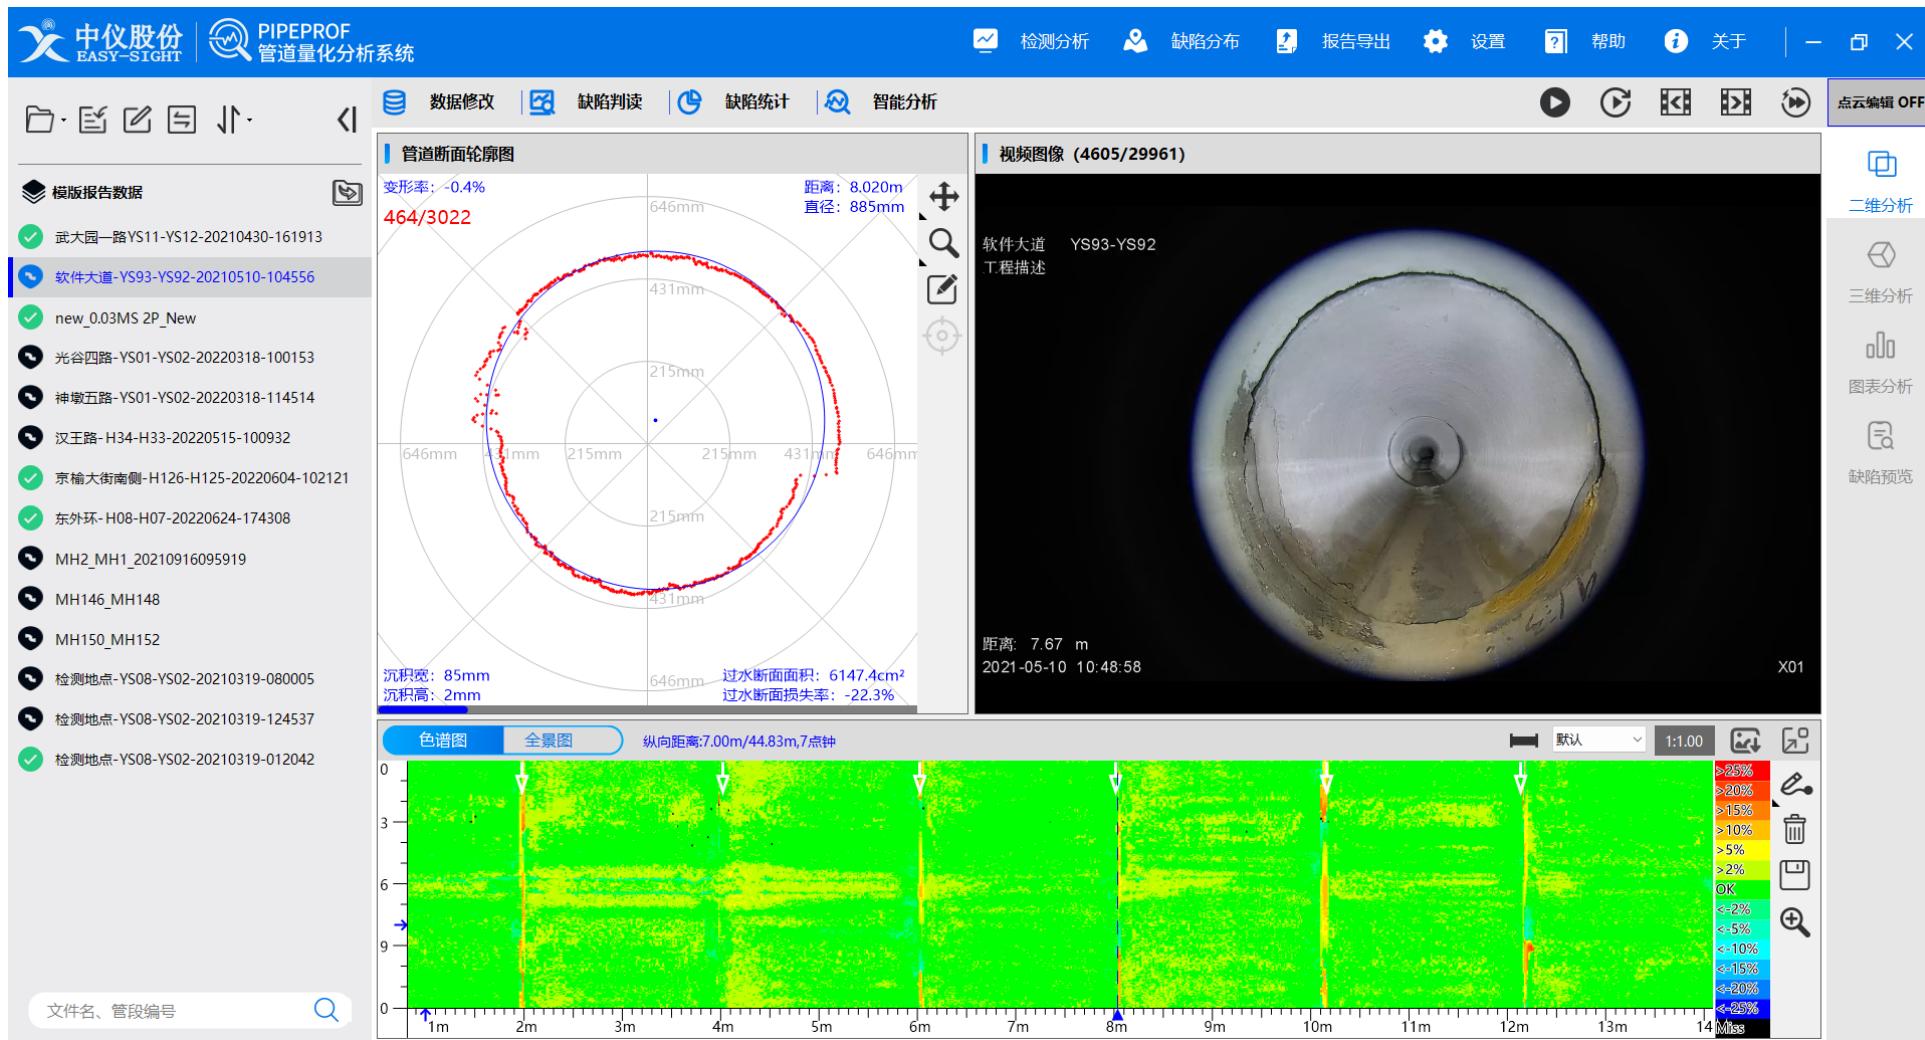
Fuzhou

Inspection of DN800 pipeline, length 45 meters.  
From the chromatogram, it can be seen that the interior of the pipeline is generally good, but the interface has more serious problems, such as leakage at 8 meters.

At 24 meters, the same problem, the interface fell off, and we can see that it has been repaired

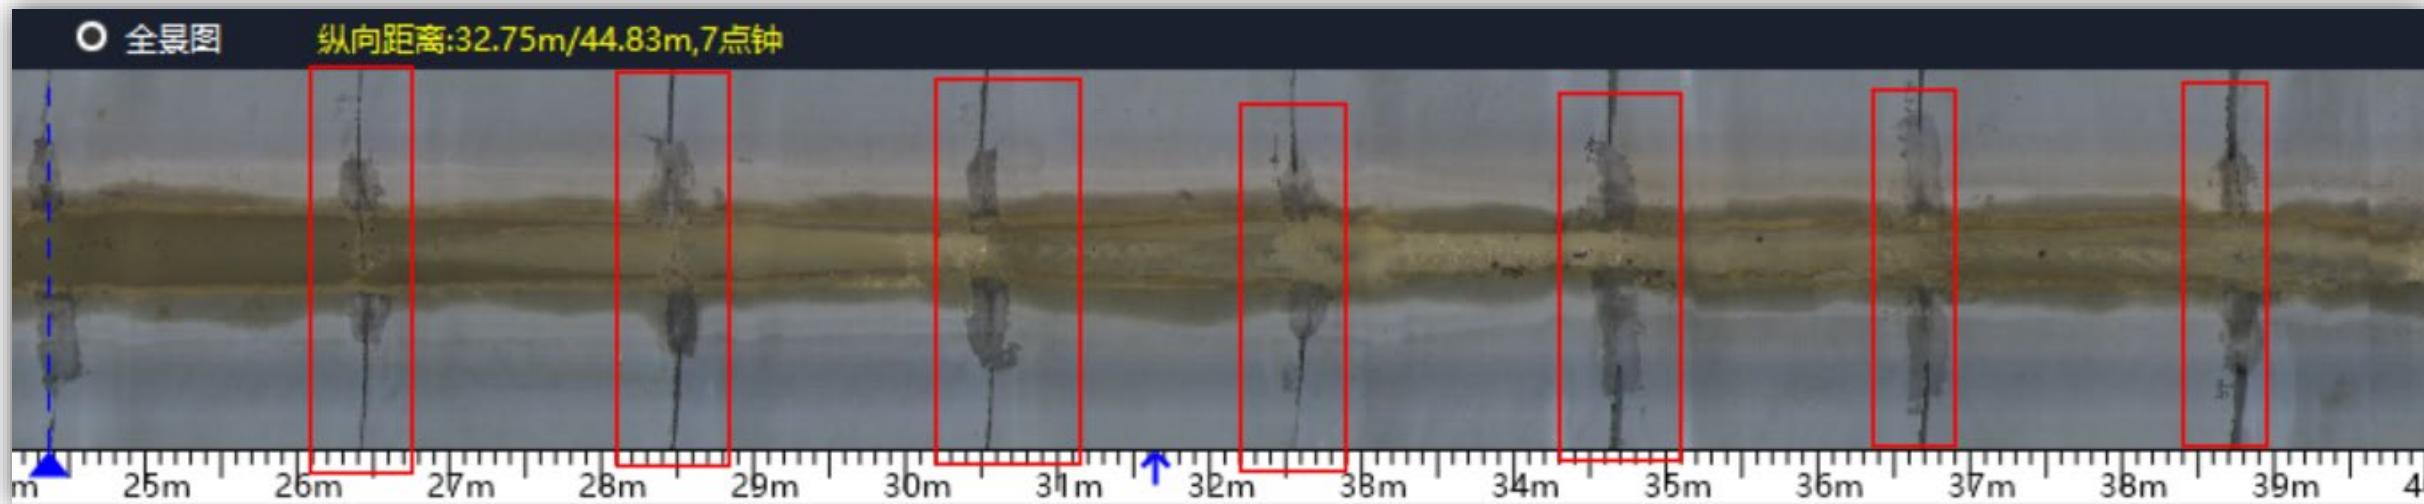
Fuzhou

Through the panoramic view, we can clearly see that this problem exists at almost every joint of the pipeline, and all have been repaired. Each pipe section is in good health. This is something that cannot be directly observed using current CCTV.
